CONDITION REPORT

STAINED GLASS EAST WINDOW

**THE ANGLICAN CHAPEL
NEWTOWN ROAD CEMETERY
NEWBURY BERKS**

August-October 2011

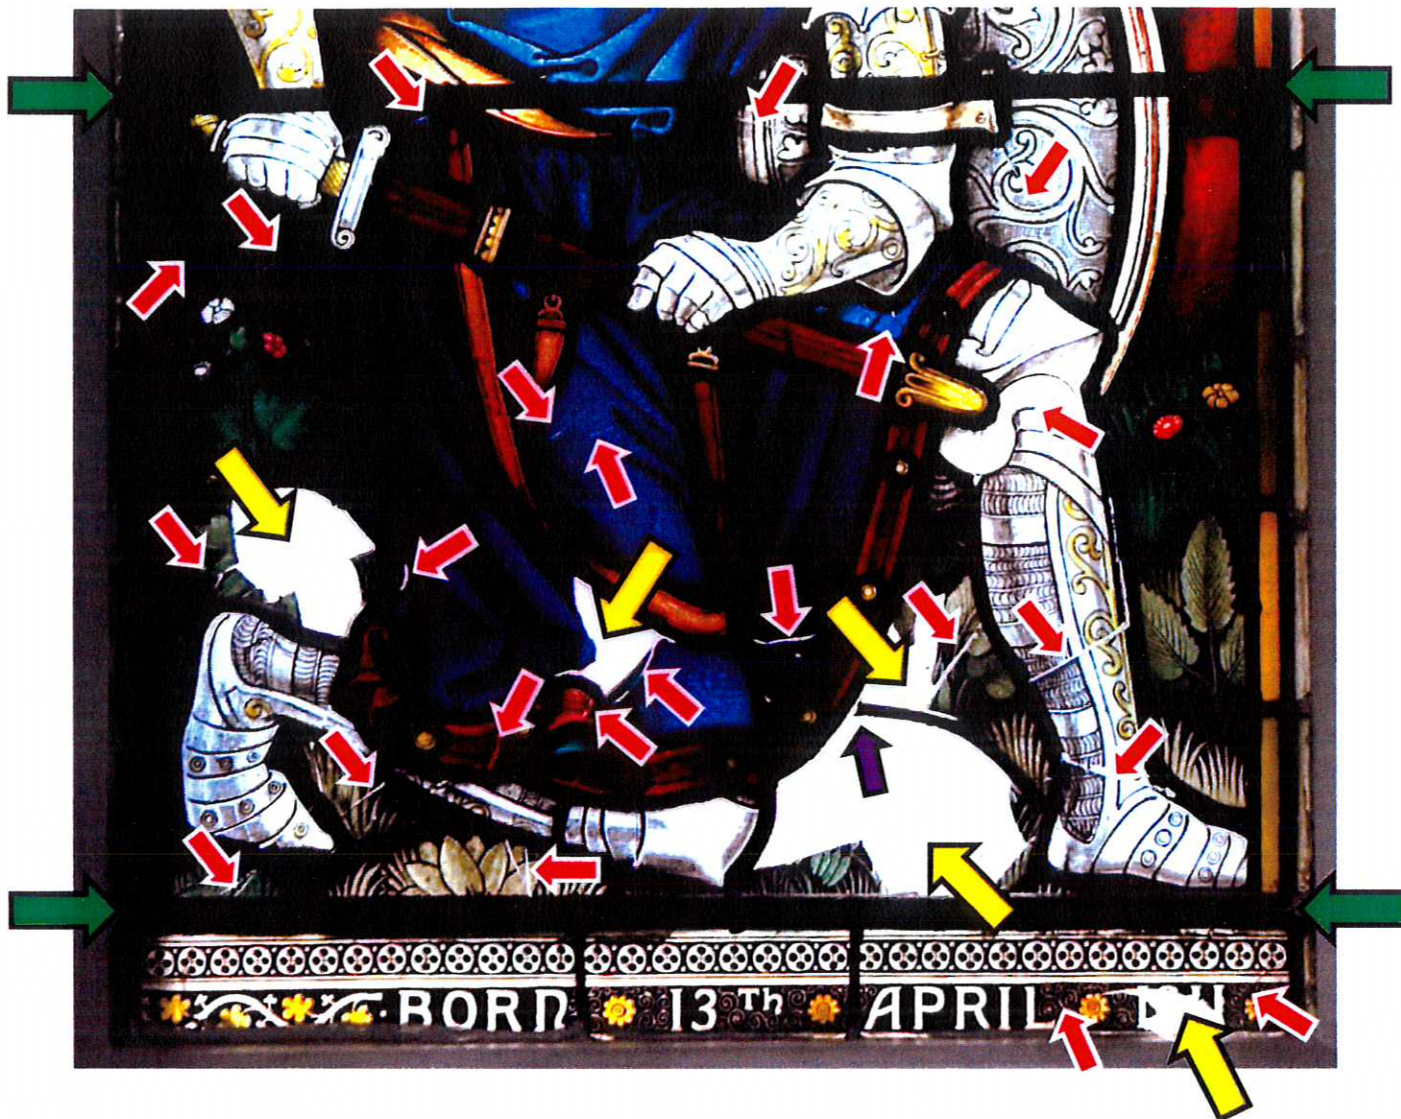
LIGHT a (detail) bottom of Panel 1a

PHOTO 5 18.08.2011 colour somewhat bleached on computer in order to reveal damage

obvious glinting cracks. There are additionally a considerable number of hairline cracks observed on site and clearly visible when the photo is magnified on the computer.

area of missing glass due to breakage. From left to right there are 4 areas:

tie bar, rusted, with loose ties, see PHOTO 6. The upper bar is somewhat bent.

because the glass piece has broken and dropped out, the lead calm has parted from its adjoining calm and hangs free.

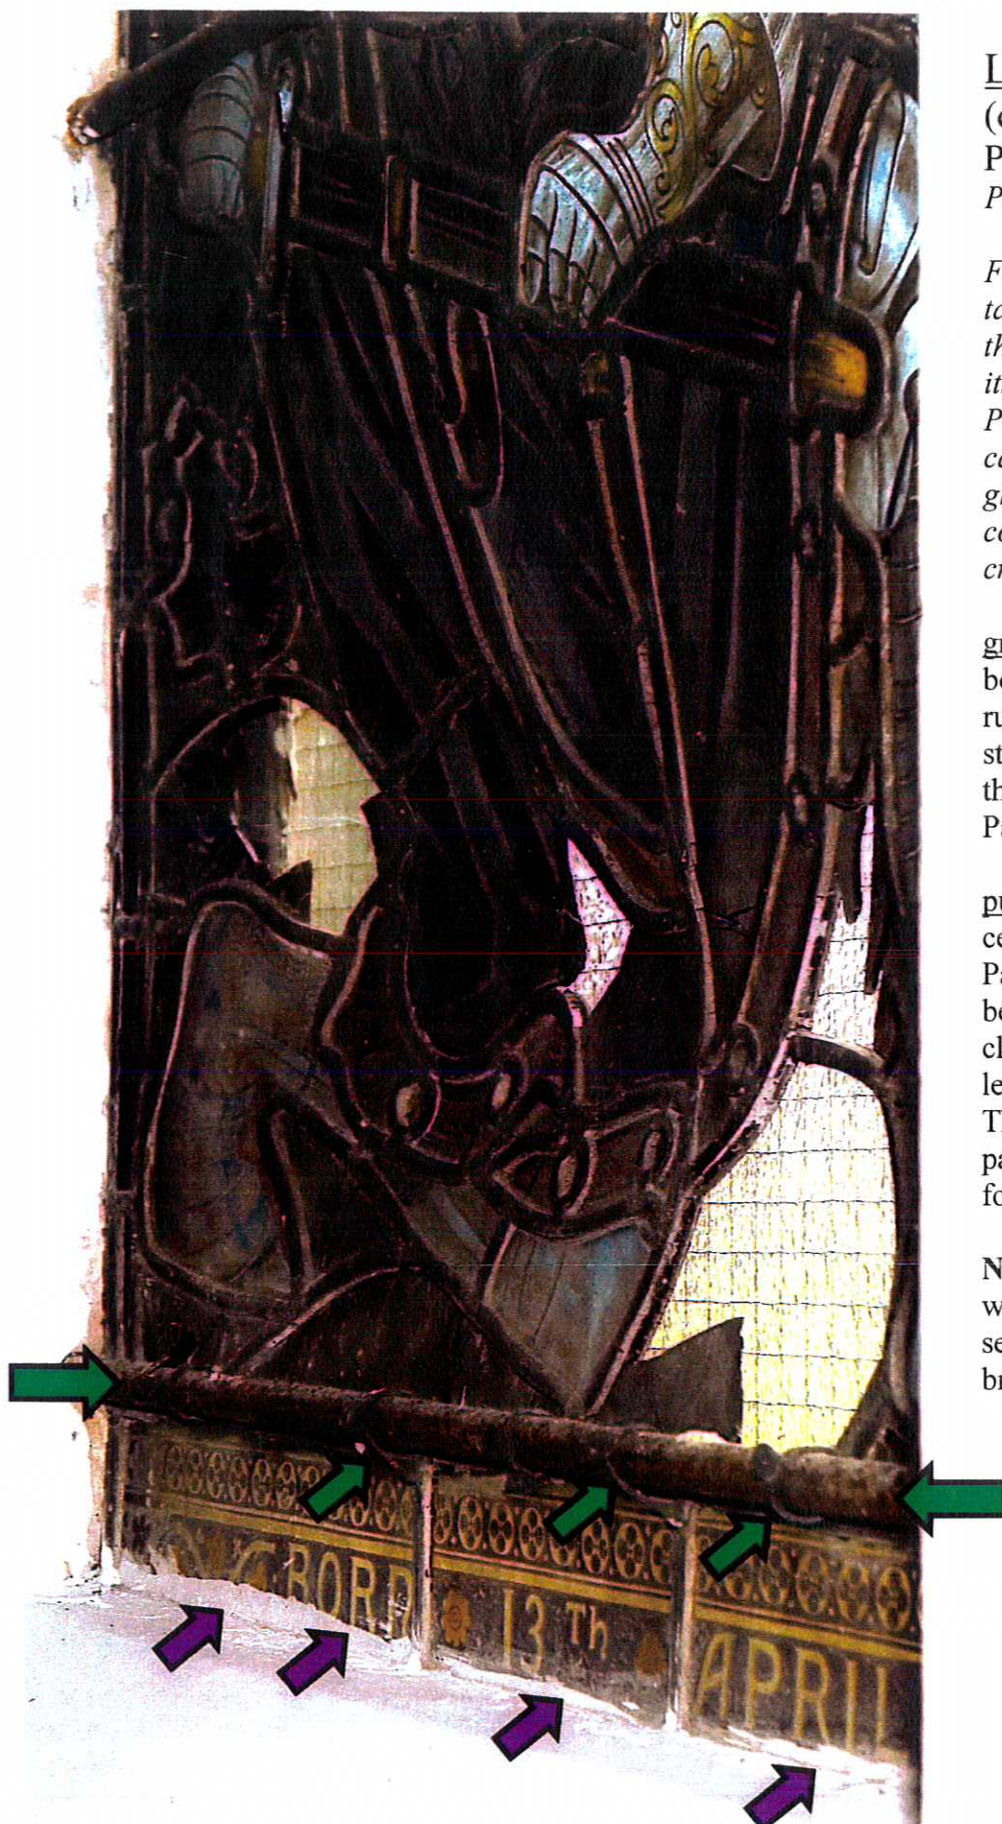
(detail) bottom of
Panel 1a

Glazing: Lead. Flat, beaded, of various appropriate widths. The leading of Panel 1a is weak, seen in the noticeable bowing *PHOTO 6*, deliberately taken with flash and at an angle to reveal that the Panel is not flat. The solder joint has broken on the lead above the large right-hand bottom hole *PHOTO 5*. The glass piece painted as leg armour is coming out of its lead, shown by the line of light to the right of the shin.

Flash photo deliberately taken on the slant to show that the leadwork has lost its proper rigidity so the Panel is bowing and causing pressures on the glass pieces which are consequently cracking/breaking.

bottom tie bar heavily rusted, with its ties stretched and loose, therefore not holding the Panel in position securely.

cement used to seal the Panel into the stone sill has been spread too thickly and clumsily so it obscures the lettering of the inscription. This cement against the painted details is not good for the glass paint.

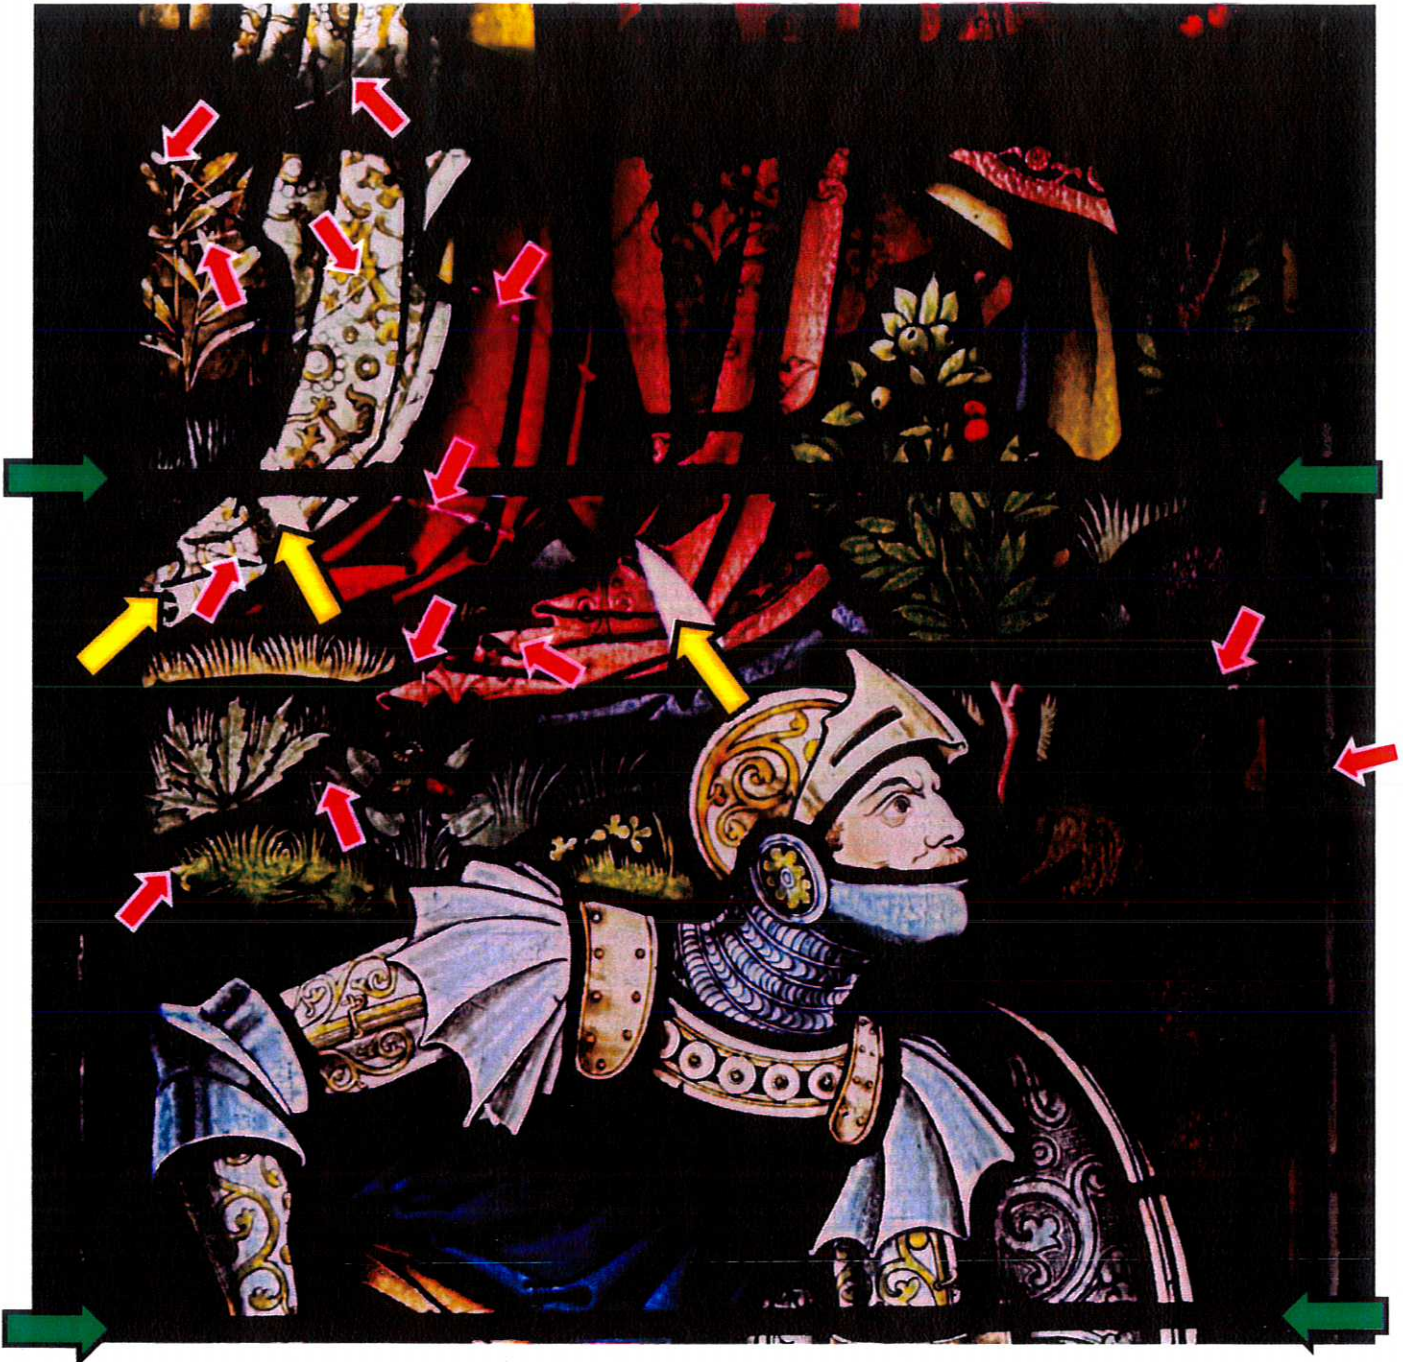
LIGHT a (detail) Panel 1a upper

obvious glinting cracks. There are additionally hairline cracks observed on site and visible when the photo is magnified on the computer. A particularly cracked area is in the upper left-hand area: a plant and to its right the white cloak diapered with silver stain of Mary Magdalene, recognizable by her long golden hair. The 2 cracks across her scarlet robe are conspicuous because of the shaling of the ruby layer of 'flushed' glass used for this garment.

area of missing glass due to breakage. From left to right there are 2 areas:

1. diapered white cloak: a triangular piece missing, but part of it appears to be jammed behind the Panel and its protective outer window; a small area at the bottom of the cloak;
2. long triangular shape missing in the rose-hued cloak of the Virgin Mary, painted with half-tone ;

green arrow: tie bar, rusted.

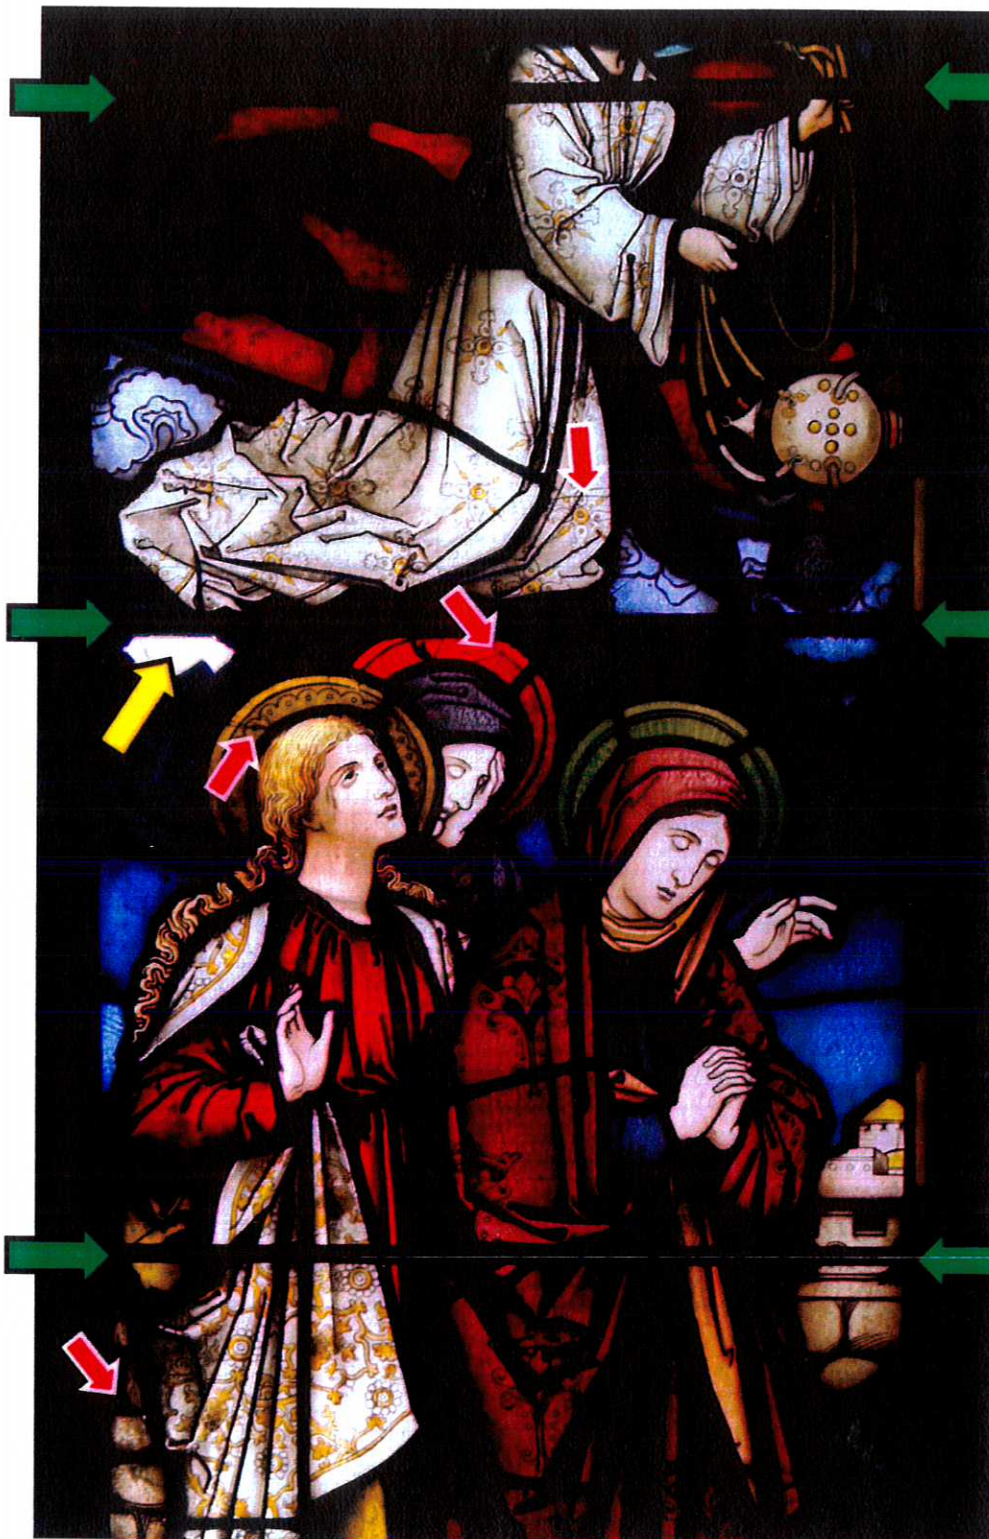
LIGHT a
1a upper/2a

red arrow:
cracks, in particular, clusters in 2 of the haloes. The glass in this photograph is less damaged than the parts below.

yellow arrow:
area of broken and missing glass: blue glass indicating sky.

green arrow:
rusted tie bars. The middle green arrows indicated the division between the 2 Panels that comprise this Light.

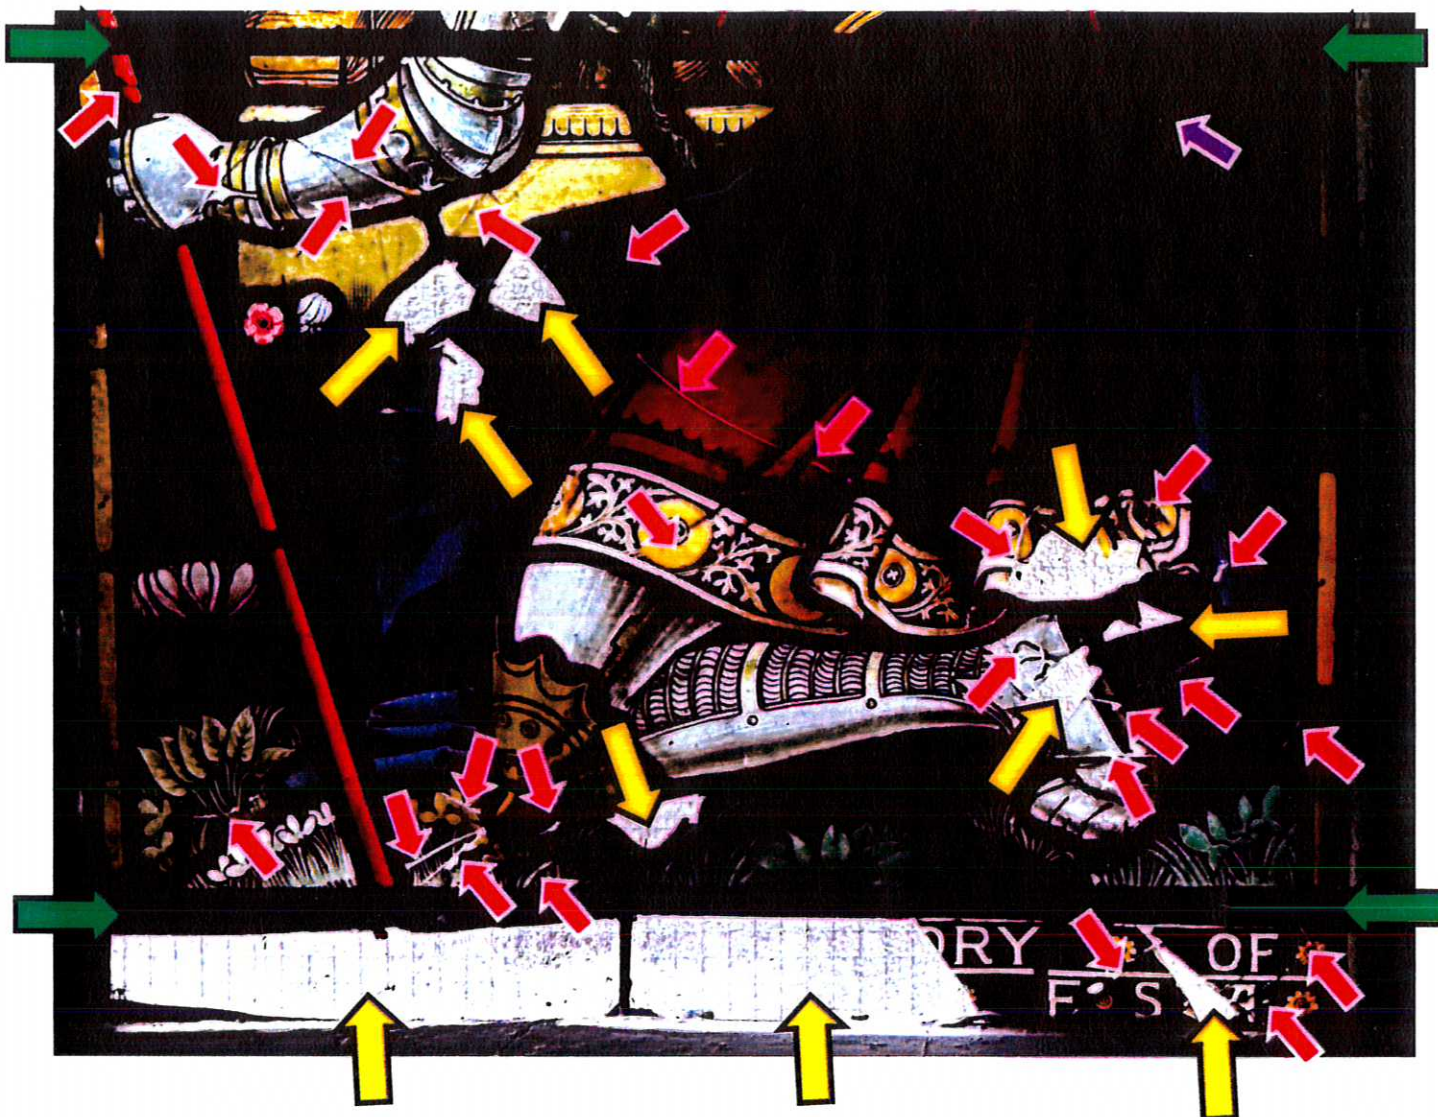
LIGHT b (detail) bottom of Panel 1b

obvious glinting cracks. There are additionally widespread hairline cracks observed on site and visible when the photo is magnified on the computer. The crack across the soldier's scarlet robe is conspicuous because along the line there is some loss of the ruby layer of 'flashed' glass used for this garment.

area of missing glass due to breakage. From left to right there are 5 areas:

1. there are 3 connected areas of blue glass with painted folds of the soldier's cloak;
2. part of the white border of the tunic decorated with painted and stained motifs ;
3. green glass with painted tufts of grass;
4. area grey-blue glass painted detail of armour-plated left foot; connected area of right foot;
5. large area of inscription, deduced to be '(IN LOVING MEMORY OF (HENRY GODWIN) F.S.(A.).'

tie bar, rusted.

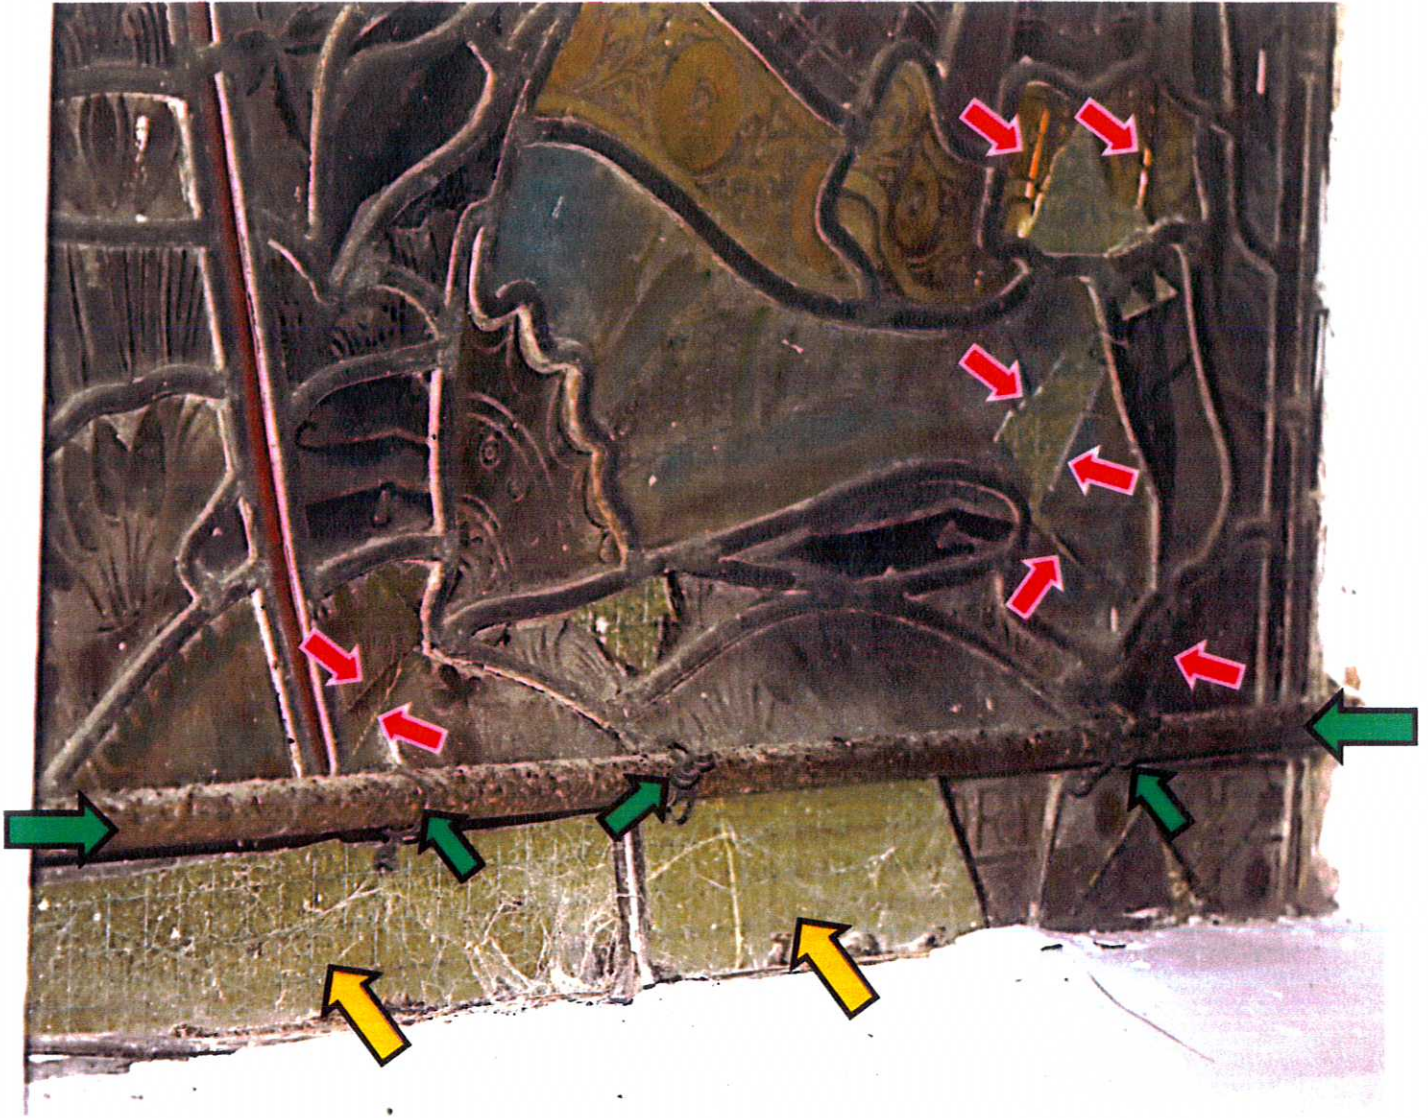
LIGHT b (detail) bottom of Panel 1b PHOTO 11 18.08.2011

Ties Bars and Ties These original tie bars are heavily rusted *PHOTO 11* and their ties are weak, or are loose or missing, therefore not doing their job of holding the Panels securely in position. The tie bar in Panel 2b level with Christ's shoulders is sloping way out of position *PHOTO 17* causing stress on the glazing and consequent cracking of adjacent glass pieces.

heavily rusted tie bar with ties stretched and loose, therefore not holding the Panel securely in position.

glinting cracks

missing glass inscription showing the wired glass of the protective OUTSIDE window.

NB the base of the Panel abutting the sill in a bad state, the lead lifting on the left. Plaster sealant clumsily against the glass towards the right under remaining part of inscription 'ORY.' Patches of mortar repair in right-hand corner.

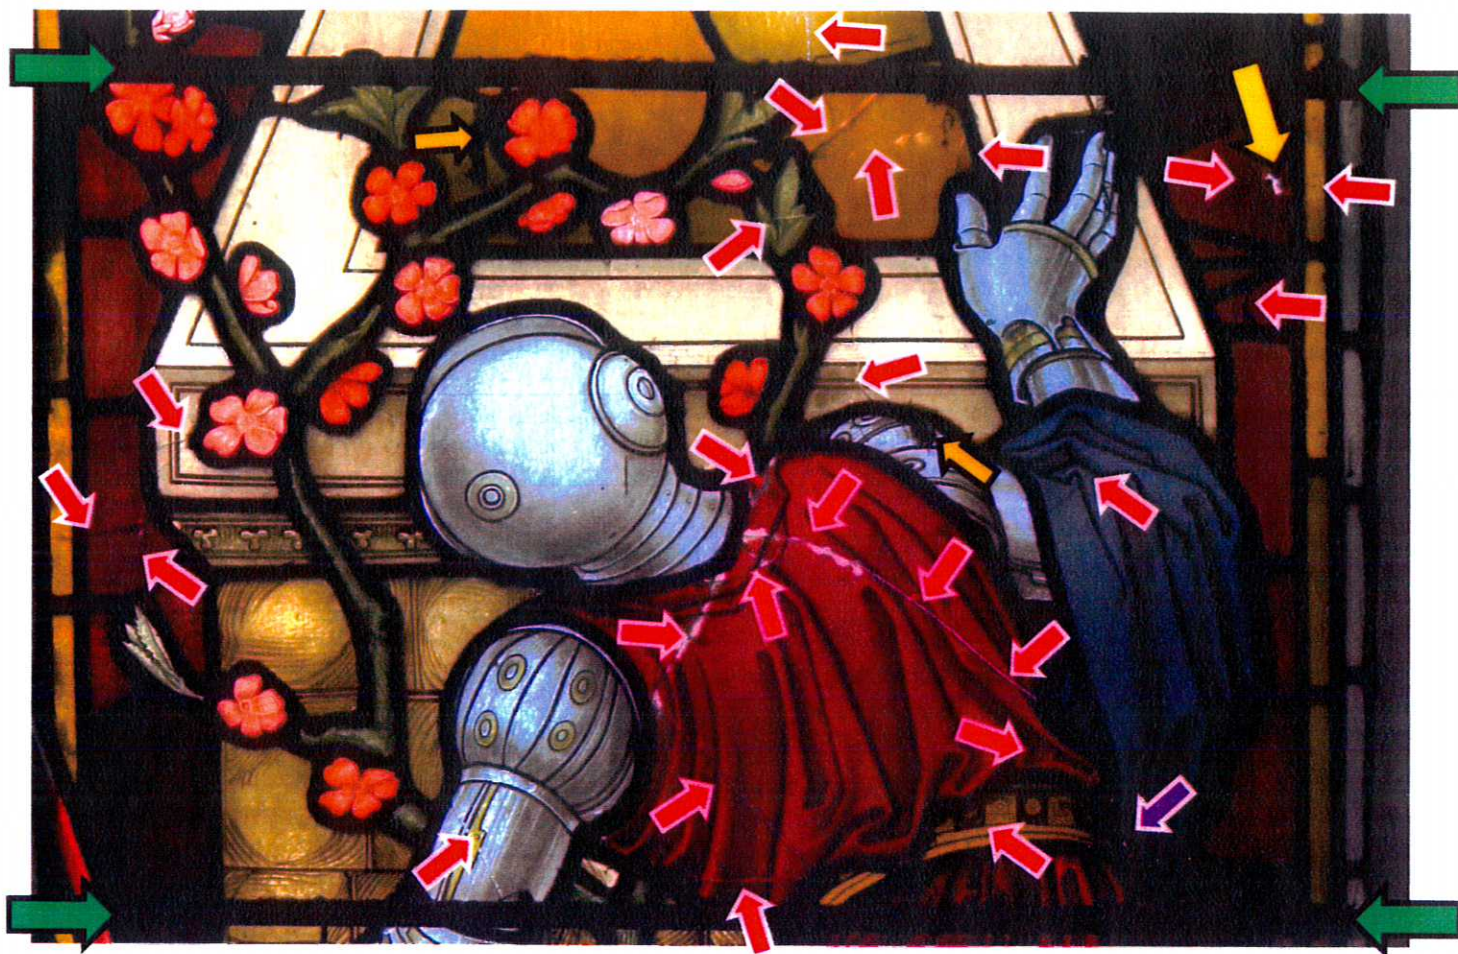
LIGHT b (detail) middle part of Panel 1b

many obvious glinting cracks. There are additionally hairline cracks observed on site and visible when the photo is magnified on the computer. The cracks across the soldier's scarlet robe are conspicuous because there is shaling of the (ruby) layer of 'flushed' glass used for this garment. There is shaling along the crack in the amber glass indicating the open tomb above the soldier's right hand.

tie bars, rusted. The upper one appears sloping to the right.

NB the only obvious repair, below hole: cluster of 3 mending leads traverse this piece, for details see PHOTO 13.

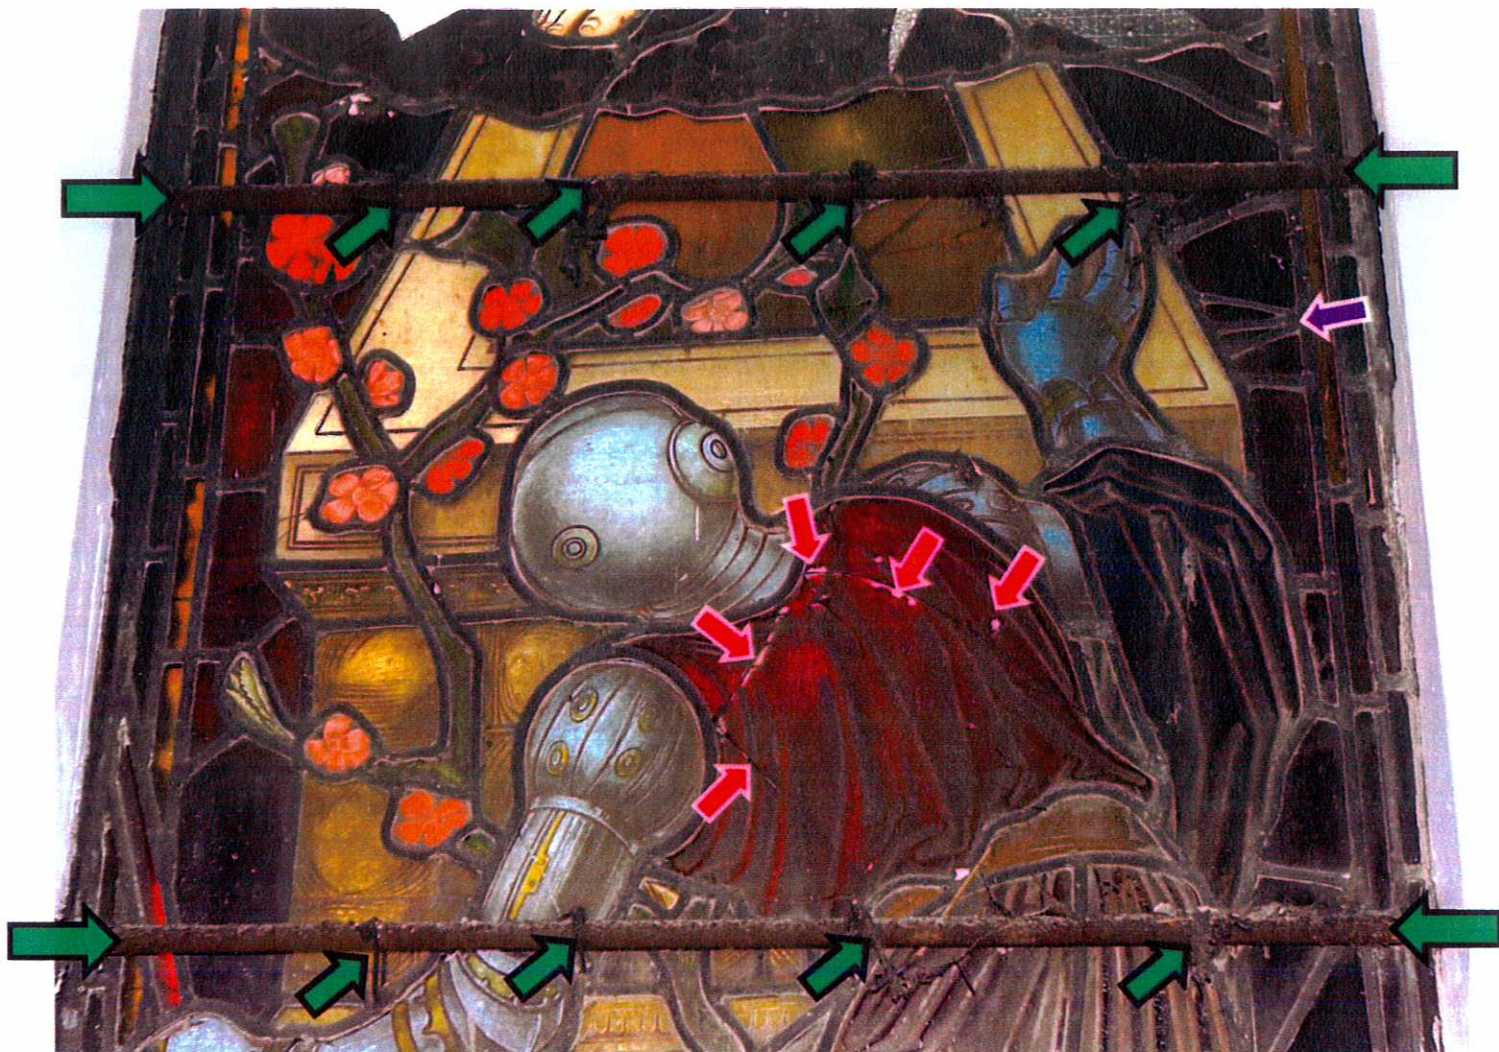
LIGHT b (detail) middle part of Panel 1b PHOTO 13 18.08.2011

4.1.1 No Obvious Evidence of Repairs None of the Lights or Tracery of this Window shows actual re-glazing. The only cluster of mending leads is seen in Light b *PHOTO 13* purple arrow. As it explains in the commentary, these are probably 'face leads' repaired in situ.

heavily rusted tie bar with ties stretched and loose, therefore not holding the Panel securely in position. These loose ties are festooned with cobwebs.

cracks in the red (ruby) flashed glass: the top thin layer of red glass it has shaled revealing the clear glass below.

cluster of 3 mending leads. We believe they are 'face leads' applied in situ.

NB this PHOTO shows how dirty the entire surface of the glass is.

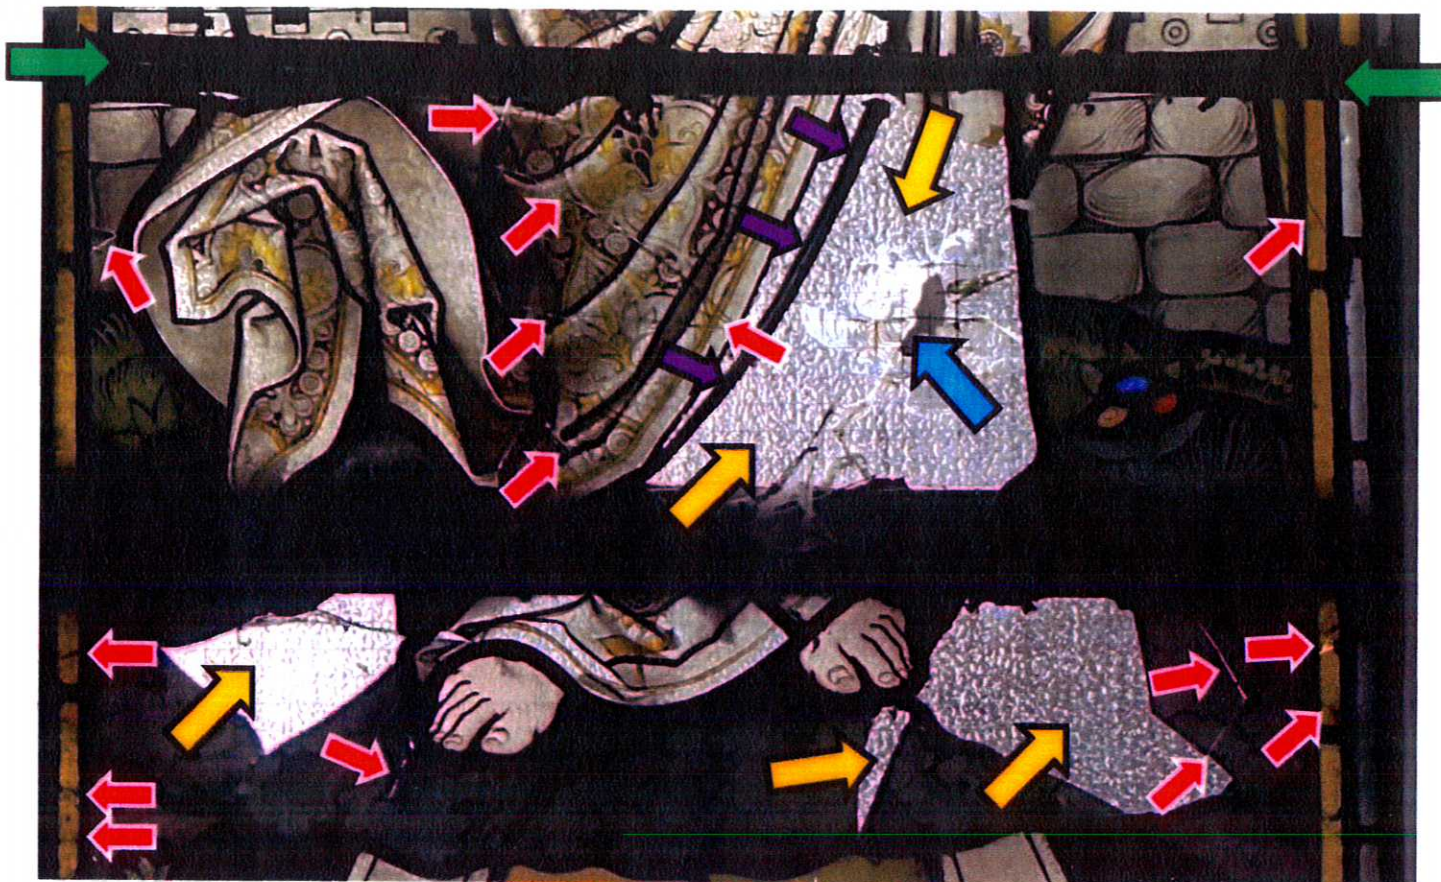
LIGHT b (detail) upper part of Panel 1b

obvious glinting cracks. There are additionally hairline cracks observed on site and visible when the photo is magnified on the computer.

area of missing glass due to breakage. From left to right there are 3 areas:

1. left: area of grey glass painted to represent clouds; right: 2 connecting areas of grey glass clouds;
2. large area of white glass: Christ's robe decorated with a diaper pattern of a painted and stained sunflower motif.

wired glass of protective OUTSIDE window damaged by strong impact: hole and allied cracks.

tie bar, rusted and slightly sloping to the right. Behind this bar is the leaded division between 2a and 2b. For a better view see PHOTO 15.

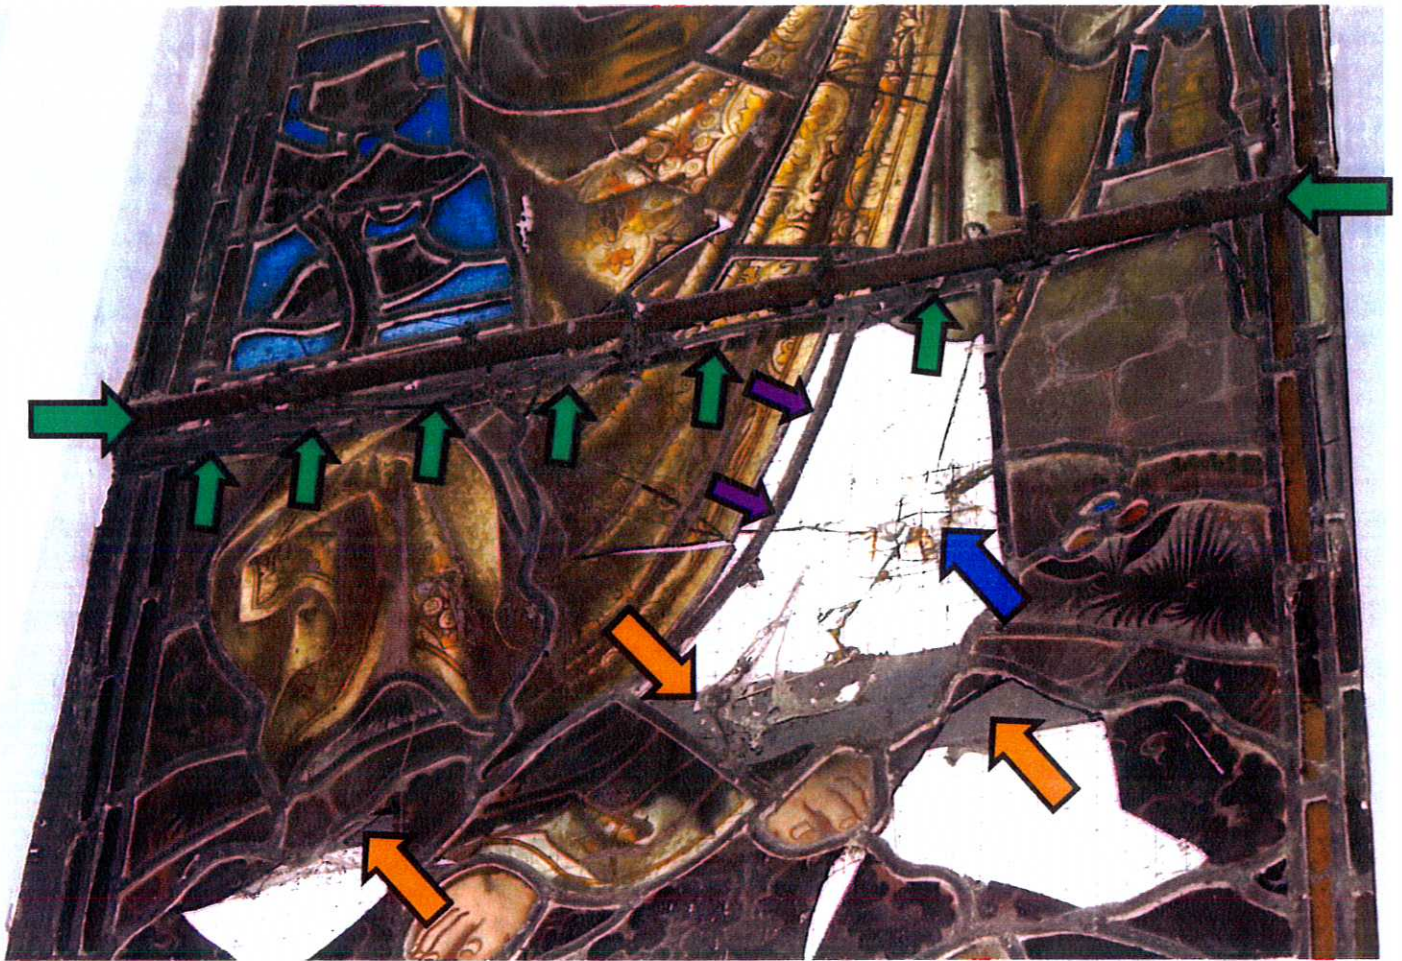
LIGHT b (detail) upper part of Panel 1b *PHOTO 15 18.08.2011*

heavily rusted tie bar with ties stretched and loose, therefore not holding the Panel securely in position. The ties are festooned with cobwebs.

wired glass of protective OUTSIDE window damaged by strong impact: hole and allied cracks. It seems that tiny remnants of the missing glass from Christ's robe (description under *PHOTO 14*) are adhering to the area around the impact hole.

NB this *PHOTO* shows how dirty the entire surface of the glass is.

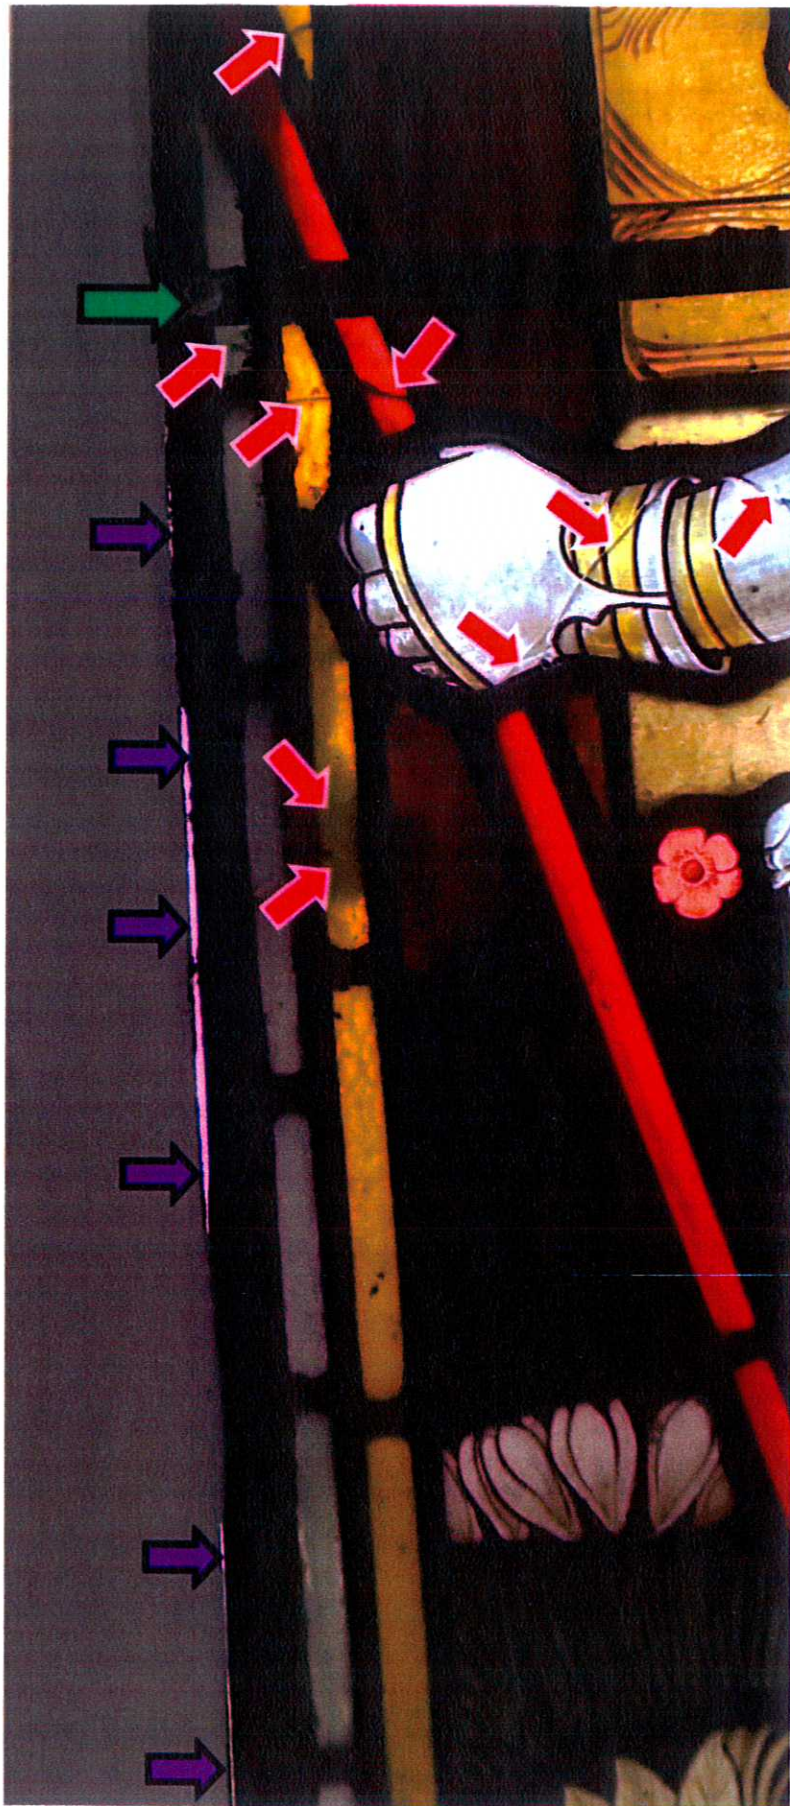
(detail) bottom left of Panel 1b

Flash photo deliberately taken on the slant to show that the leadwork has lost its proper rigidity so the Panel is bowing and causing pressures on the glass pieces which are consequently cracking.

red arrow:
cracks

green arrow:
tie bar heavily rusted.

purple arrow:
light showing because the lead frame of the Panel has come away from the stone mullion.

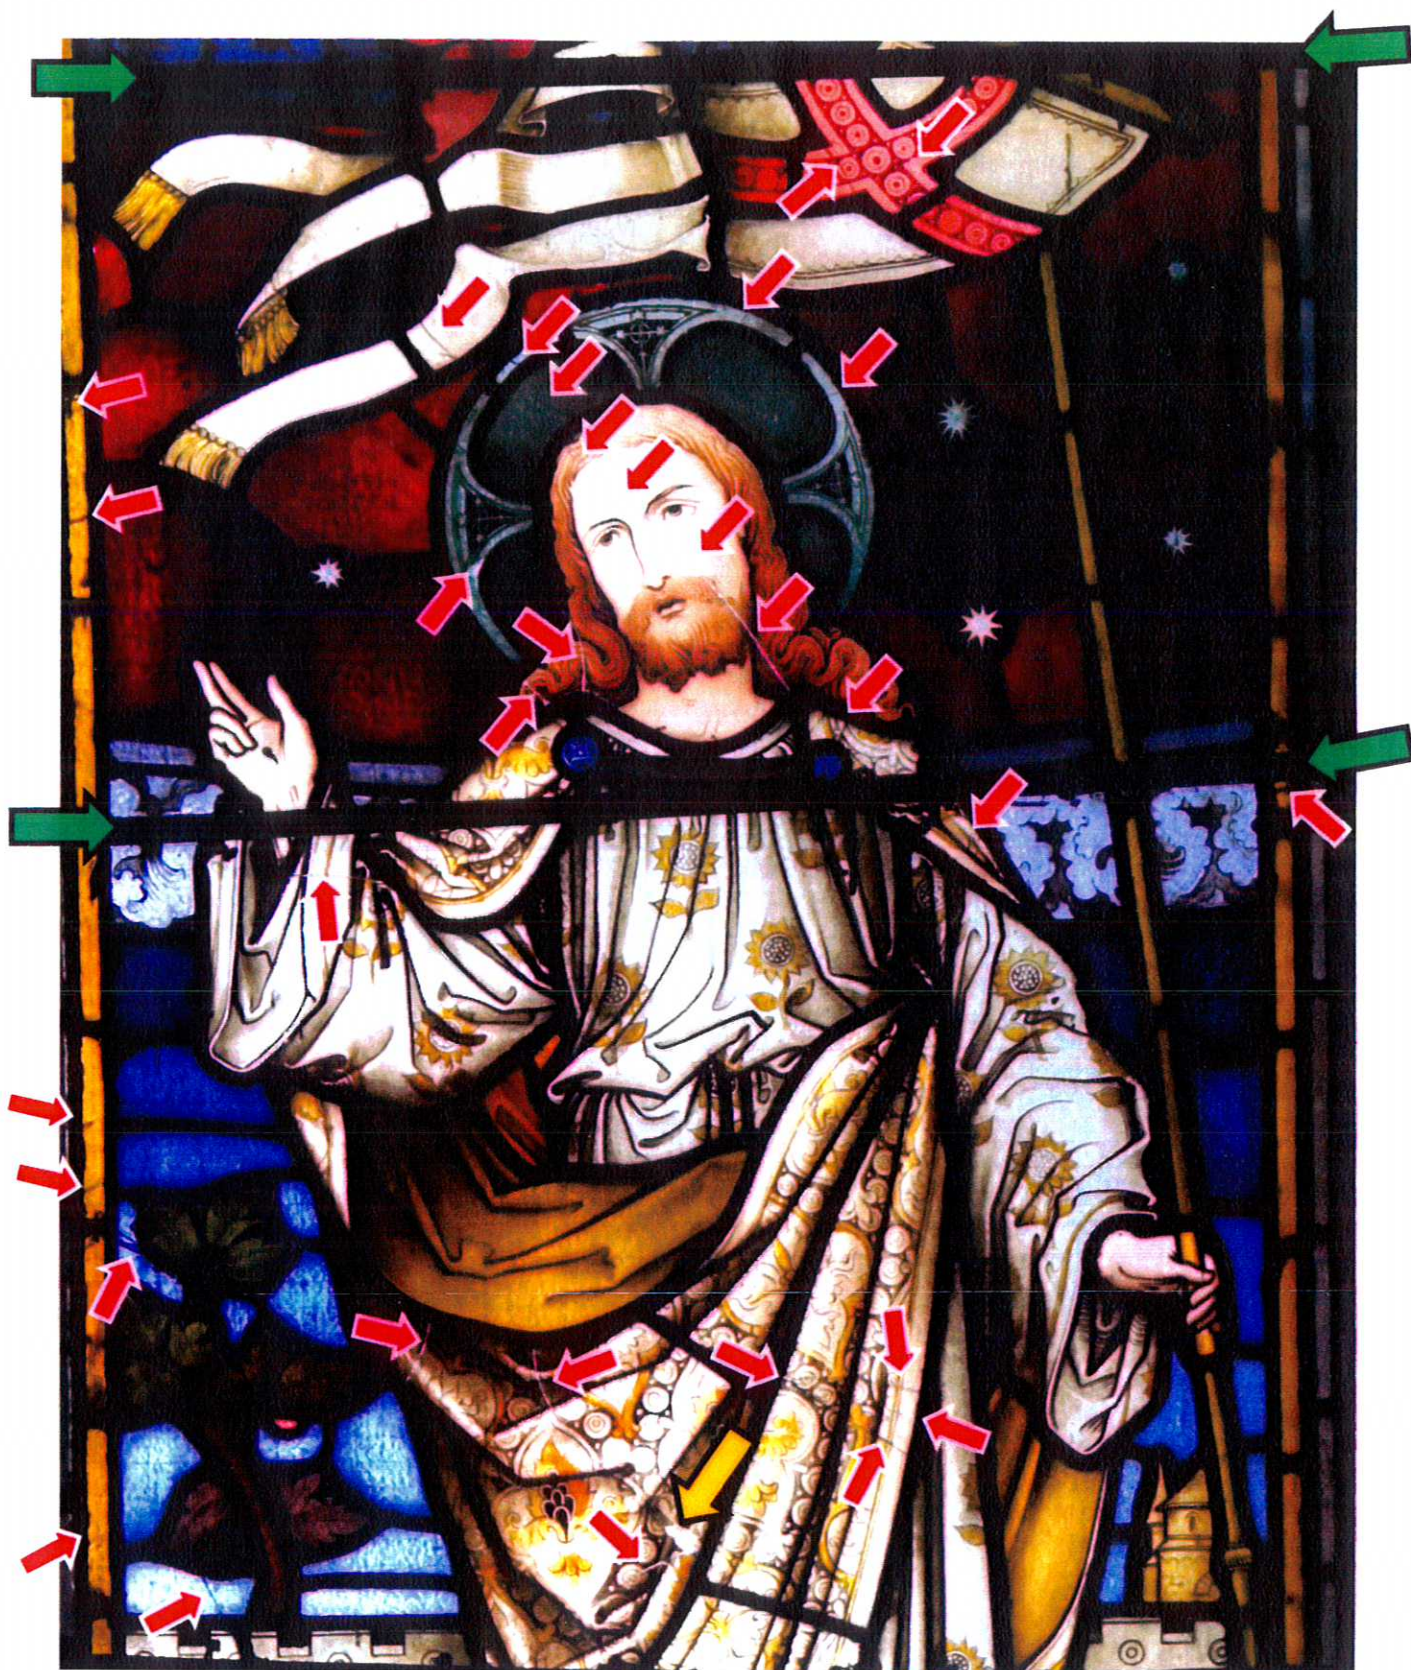
LIGHT b (detail) Main Part of 2b excluding windowhead cusp PHOTO 17 18.08.2011

red arrow: obvious cracks in glass. Additionally there are some hairline cracks visible when photo is magnified on the computer.

yellow arrow: hole in white glass, painted and stained with complex diaper pattern.
