CONDITION REPORT

STAINED GLASS EAST WINDOW

**THE ANGLICAN CHAPEL
NEWTOWN ROAD CEMETERY
NEWBURY BERKS**

August-October 2011

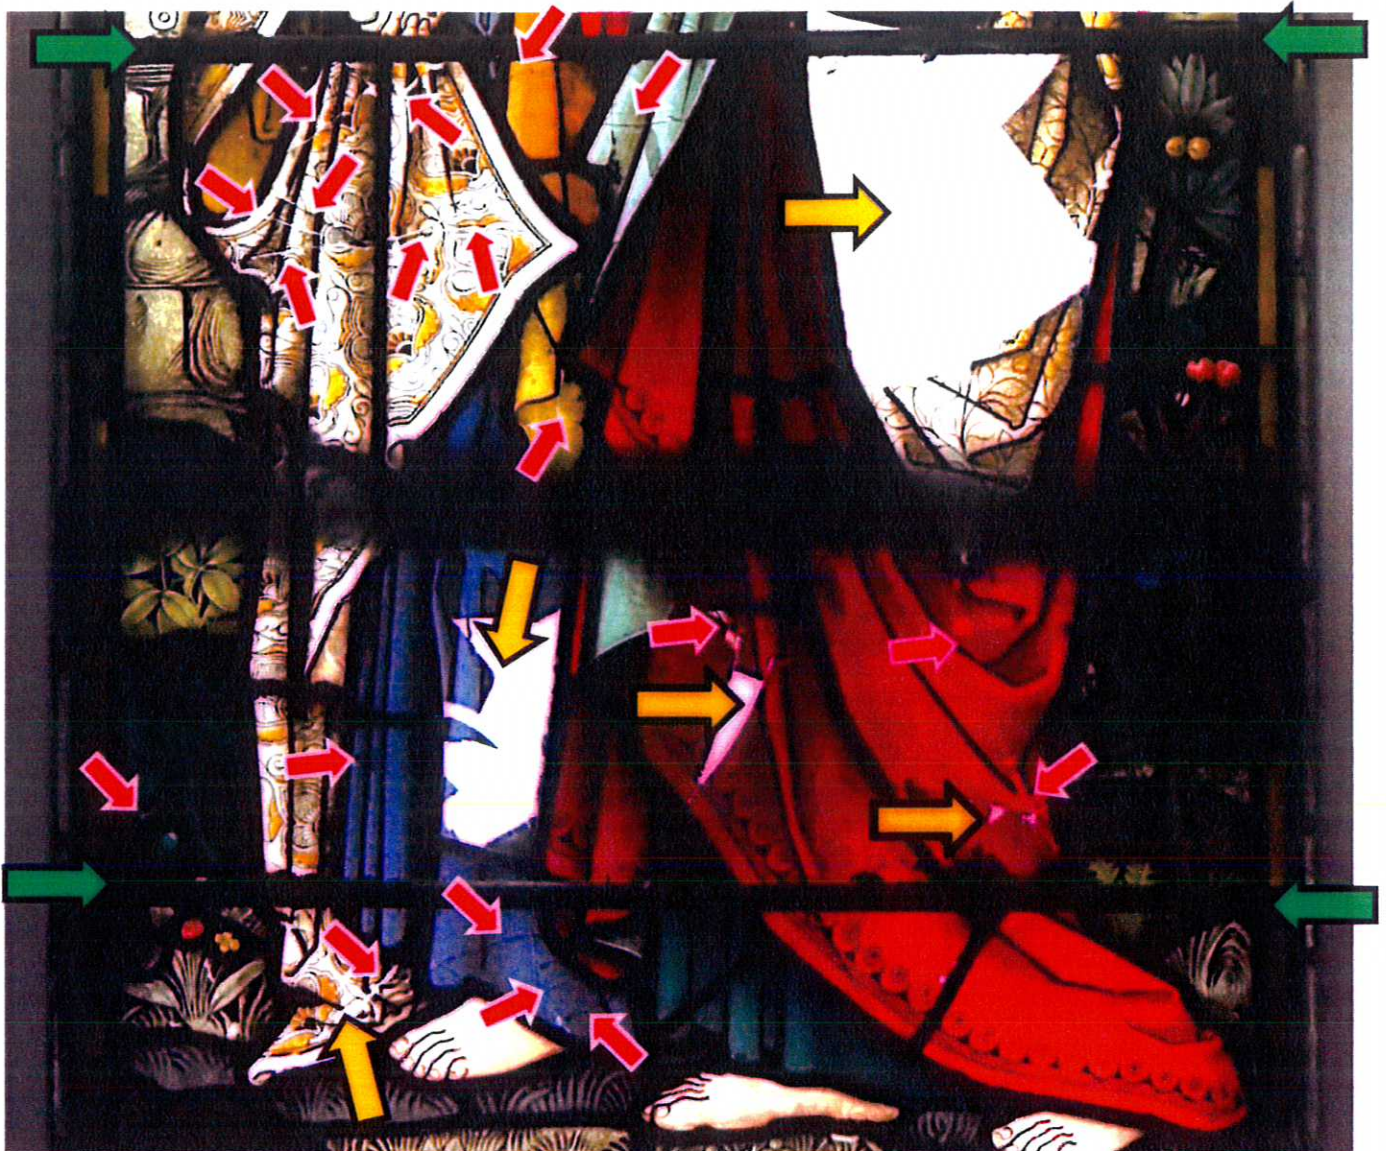
LIGHT c (detail) Middle Part of Panel 1c

NB the protective OUTSIDE window of wired glass is seen through the areas of broken and missing glass. The shadow of its division bar creates a wide dark horizontal line across this Panel.

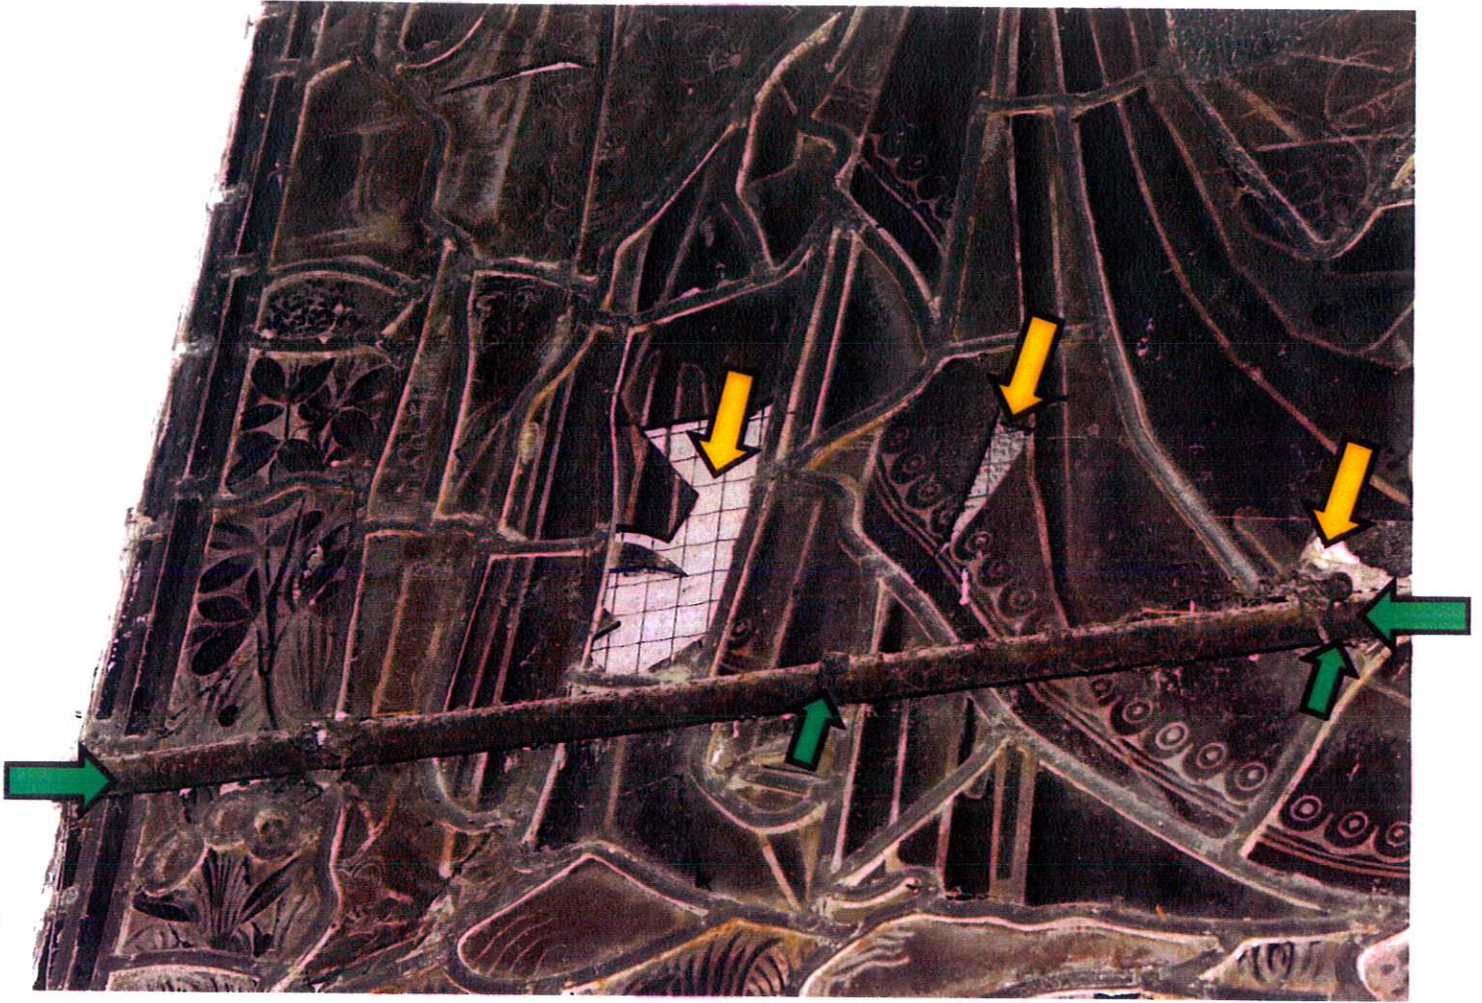
LIGHT c (detail) Middle Part of Panel 1c PHOTO 21 18.08.2011

Ties Bars and Ties These original tie bars are heavily rusted *PHOTO 21* and their ties are weak, or are loose or missing. Therefore the tie bar is not fulfilling its function of supporting the panels in position.

1. The protective OUTSIDE window of wired glass is seen through the areas of broken and missing glass.
2. This part of the Light is exceptionally dirty. In particular, see
 - i) a very dusty cobweb remnant hanging down from the censing angel's robe covering the feet ;
 - ii) marks on the censing angel's neck; the faces of the 2 male saints;
 - iii) dirt apparently trapped on the protective OUTSIDE window, seen in the areas of missing blue glass, see yellow arrow, 3. above.

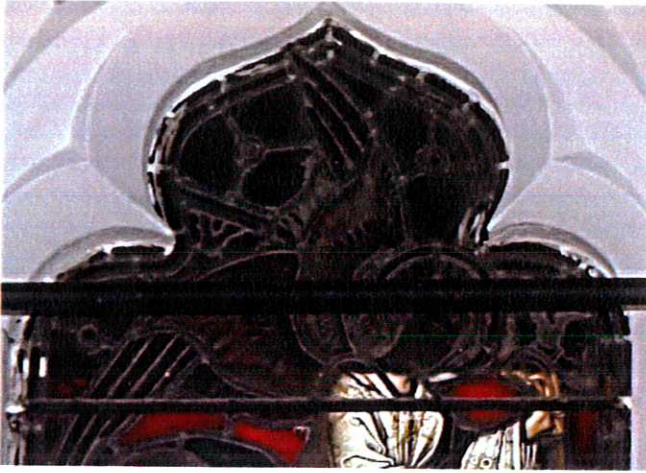
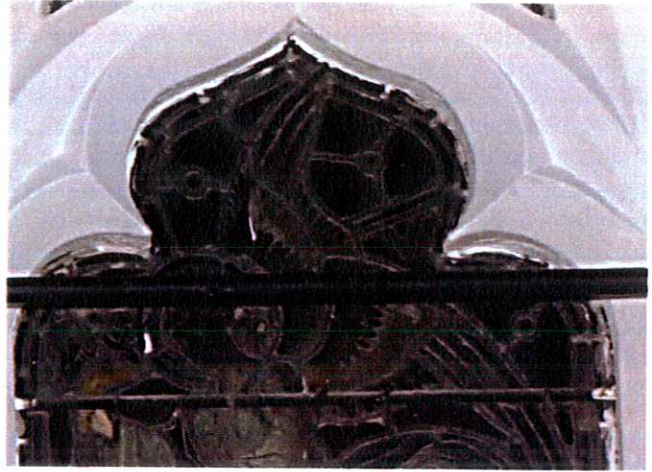
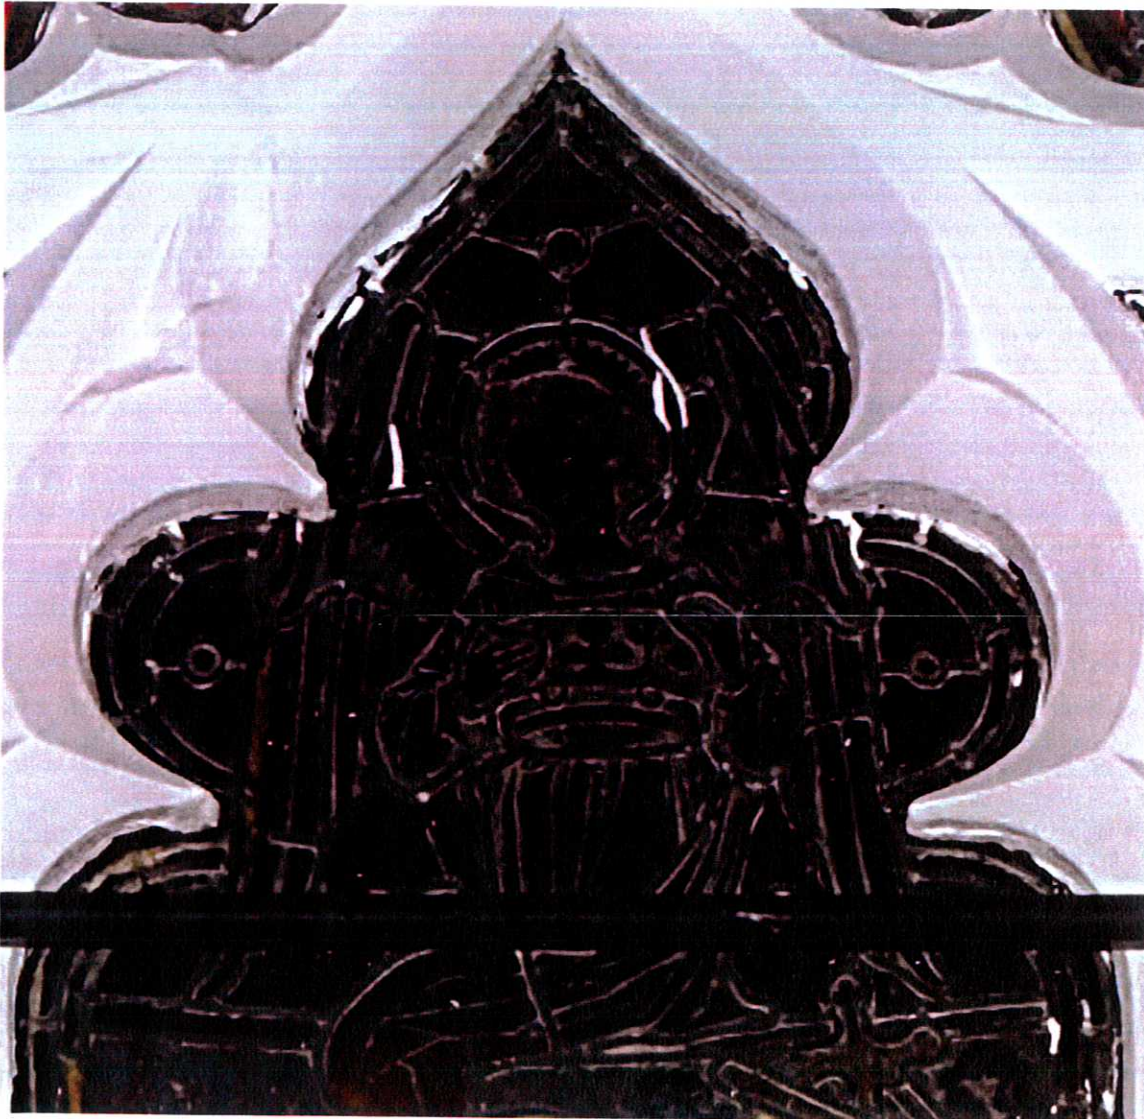
The flash *PHOTOS* of the 3 windowheads, blacked out by the protective metal sheet of the *OUTSIDE* window (see *PHOTO 28*), show they are intact. They have been splashed with white emulsion, demanding careful cleaning.
