CONDITION REPORT

STAINED GLASS EAST WINDOW

**THE ANGLICAN CHAPEL
NEWTOWN ROAD CEMETERY
NEWBURY BERKS**

August-October 2011

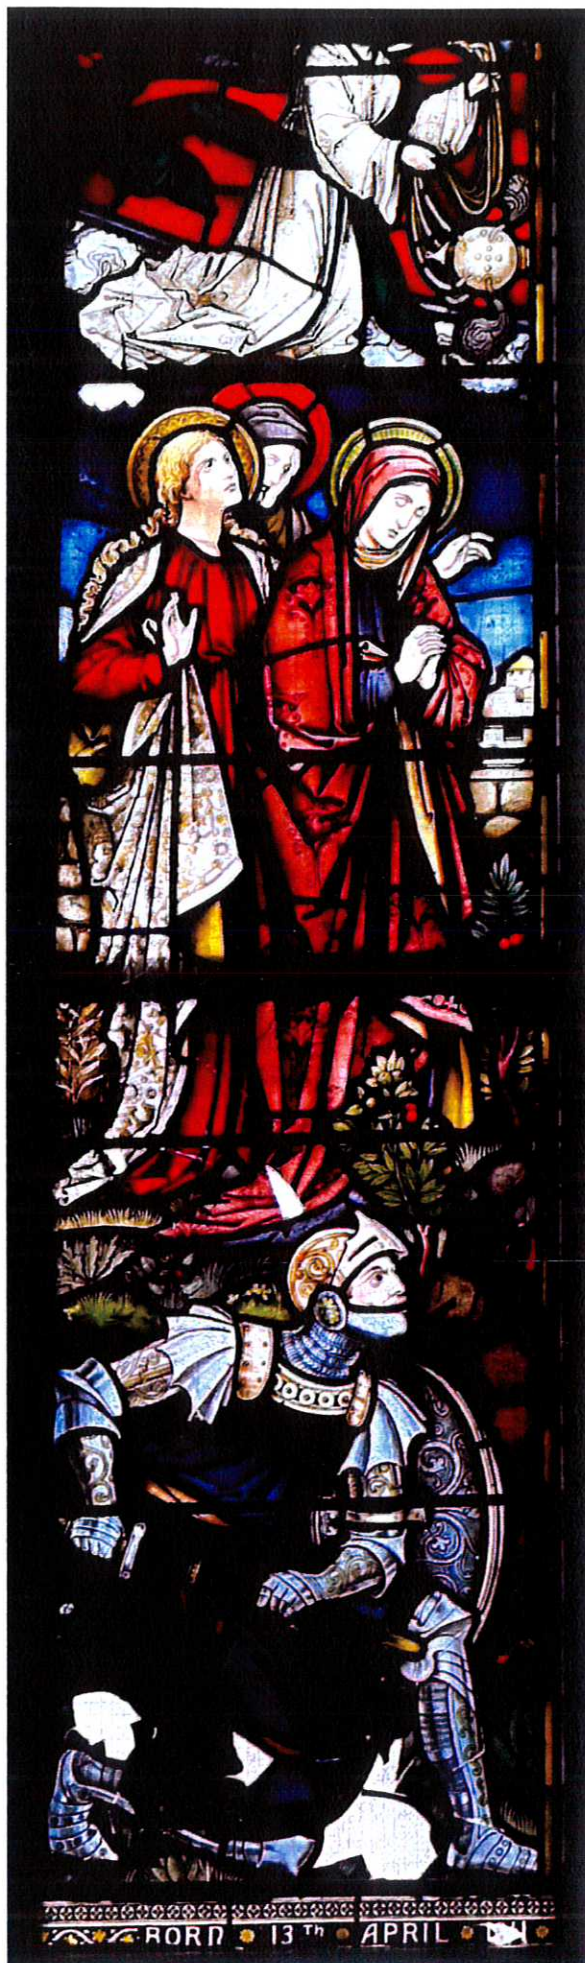
LIGHT a

General Comments The Light is made up of only 2 Panels, as indicated on Figure 2: 1a runs from the inscription up as far as the haloes of the Three Marys; 2a, a censing angel, makes up the rest of the Light including the cusps of the windowhead. These are obscured by the metal sheet of the protective window OUTSIDE, but the glass is intact *PHOTO 23*. The window suffered vandalism evident in the holes in the glass presumably before the protective OUTSIDE window was installed. The glazing which consists of all the leaded and soldered pieces of glass made rigid and watertight by the application of leaded light cement brushed under the leaf of each lead, has been gradually failing over time. This is an inevitable process because, as a general rule, lead being a malleable material eventually loses its tensile strength along with its leaded light cement that gradually begins to disintegrate, become friable and fall out. The structural weakness of the glazing grid is worsened by the slow loosening of the copper ties applied to the Panel at regular intervals along the line of the tie (fixing) bar and tied to it. The Light has many cracks (indicated by red arrows) caused by stress because of the failure of the glazing and the ties. Panel 1a is particularly subject to pressure cracks because it is so tall. Window Lights comprising several Panels spread the stress, but of course it is difficult for a designer to accommodate divisions into the design without interrupting the coherence of a scene.

Glass The lower part of Panel 1a especially the areas at the base of the soldier figure, has suffered the worst damage. It appears that before the protective window OUTSIDE was put in place, pieces of glass were vandalized, probably by throwing stones, leaving gaping holes. The missing piece in front of the kneeling knee was painted with detailed grass and plants. There is also a small hole in the inscription year date. Such holes have associated cracks. Higher up the Panel, above the soldier's helmet is an elongated triangular hole and several cracks in the adjacent flashed ruby glass due to the undue stress of the failed glazing. All red glass, termed 'ruby' by stained glass artists, is 'flushed' i.e. has a thin layer of ruby glass fused on top of the base clear glass. When it breaks, the flashed layer tends to shale, leaving patches of clear glass along the crack line, as seen in the red robes here. The glass just below the division *PHOTO 8*, has a large hole and breakage. There are pressure cracks in 2 haloes and the robe of the angel above.

Glazing: Lead. Flat, beaded, of various appropriate widths. The leading of Panel 1a is weak, seen in the noticeable bowing *PHOTO 6*, deliberately taken with flash and at an angle to reveal that the Panel is not flat. The solder joint has broken on the lead above the large right-hand bottom hole *PHOTO 5*. The glass piece painted as leg armour is coming out of its lead, shown by the line of light to the right of the shin.

Leaded Light Cement This is brittle and falling out wherever a glass piece is missing through breakage.

Ties Bars and Ties These original tie bars are heavily rusted *PHOTO 6* and their ties are weak, or are loose or missing.

The head and wings of the angel are intact as seen in *PHOTO 23* but obscured by the metal sheet of the protective window OUTSIDE.

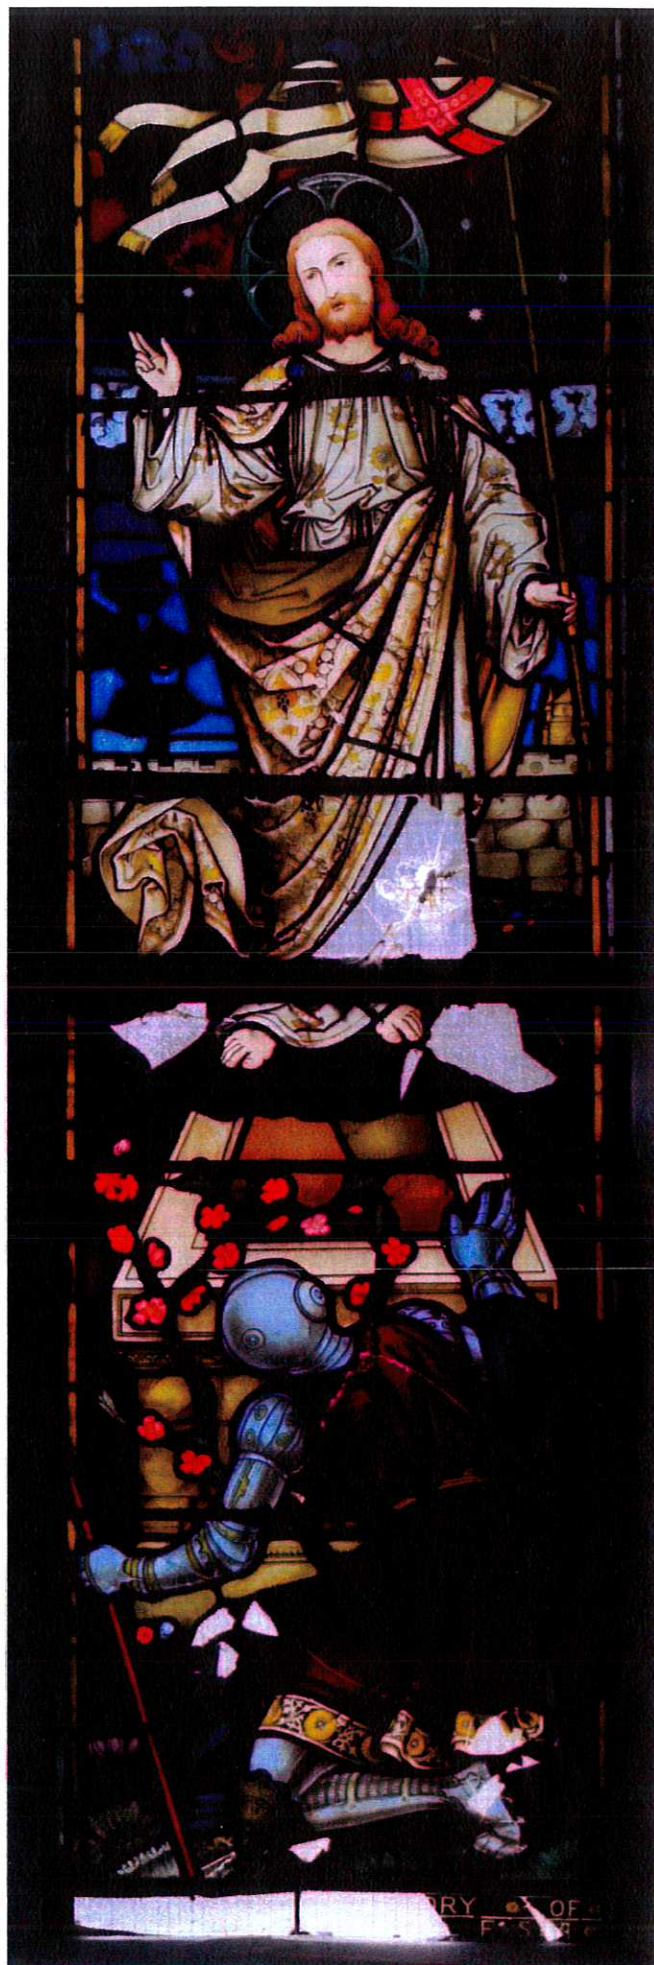
LIGHT b

General Comments The Light is made up of only 2 Panels, as indicated on Figure 2 but its structure is unlike Lights a and c: its 2 Panels are more even in size. 1a runs from the inscription up as far as the skyline and traverses the lower part of Christ's robe, thus the division of the 2 Panels interrupts the figure to a certain extent. The designer is trusting that our eyes go automatically to Christ's face and hand raised in blessing, and discount the thick line of division leads and parallel tie bar further down the figure. Above Christ's banner of victory is an angel holding a crown above triumphant Christ, making up the rest of the Light including the cusps of the windowhead. These are obscured by the metal sheet of the protective window OUTSIDE, but the glass is intact *PHOTO 25*. The window has suffered more vandalism than Light a, evident in the large number of holes in the glass presumably before the protective OUTSIDE window was installed. The glazing which consists of all the leaded and soldered pieces of glass made rigid and watertight by the application of leaded light cement brushed under the leaf of each lead, has been gradually failing over time. This is an inevitable process because, as a general rule, lead being a malleable material eventually loses its tensile strength along with its leaded light cement that gradually begins to disintegrate, become friable and fall out. The structural weakness of the glazing grid is worsened by the slow loosening of the copper ties applied to the Panel at regular intervals along the line of the tie (fixing) bar and tied to it. The Light has many cracks (indicated by red arrows) caused by stress because of the failure of the glazing and the ties.

Leaded Light Cement This is brittle and falling out wherever a glass piece is missing through breakage.

Ties Bars and Ties These original tie bars are heavily rusted *PHOTO 11* and their ties are weak, or are loose or missing, therefore not doing their job of holding the Panels securely in position. The tie bar in Panel 2b level with Christ's shoulders is sloping way out of position *PHOTO 17* causing stress on the glazing and consequent cracking of adjacent glass pieces.

The windowhead is obscured by the metal sheet of the protective window OUTSIDE but the stained glass still exists, see *PHOTO 25*. It depicts an angel kneeling facing forward with a crown held above the Risen Christ, victor over death.

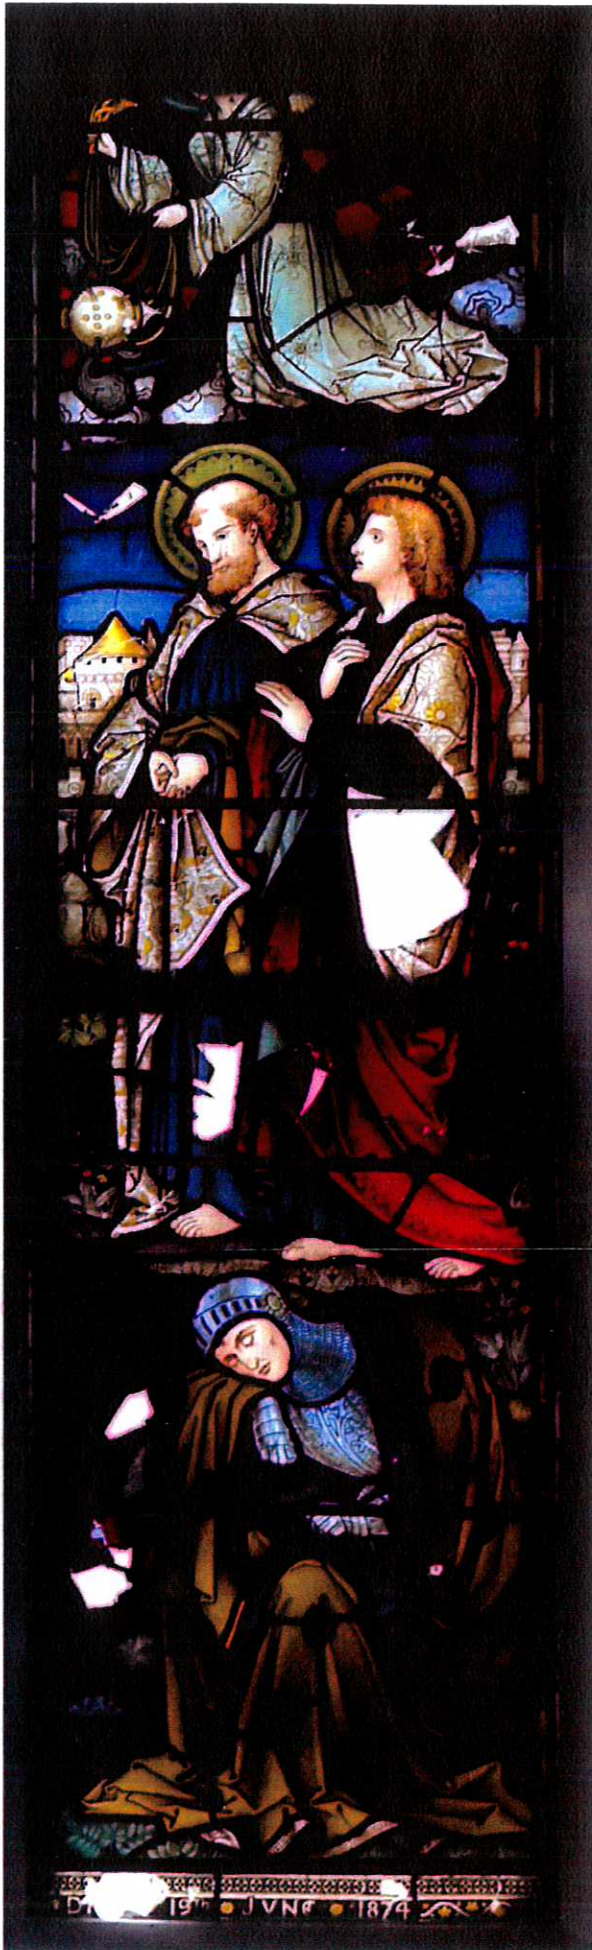
LIGHT c

General Comments The Light is made up of only 2 Panels, same format as Light a. As indicated on Figure 2: 1c runs from the inscription up as far as the haloes of St Peter and St John; 2c, a censing angel (the design of 2a, but 'handed' i.e. reversed), makes up the rest of the Light including the cusps of the windowhead. These are obscured by the metal sheet of the protective window OUTSIDE, but the glass is intact *PHOTO 24*. The window has suffered vandalism evident in the holes widespread in the glass presumably before the protective OUTSIDE window was installed. When the glazing has received so many impacts and losses of glass pieces its function of holding all the glass together in an effective grid is compromised. The structural weakness of the glazing grid is worsened by the slow loosening of the copper ties applied to the Panel at regular intervals along the line of the tie (fixing) bar and tied to it. The Light has many cracks (indicated by red arrows) caused by stress because of the failure of the glazing and the ties. Panel 1a is particularly subject to pressure cracks because it is so tall.

Leaded Light Cement This is brittle and falling out wherever a glass piece is missing through breakage.

Ties Bars and Ties These original tie bars are heavily rusted *PHOTO 21* and their ties are weak, or are loose or missing. Therefore the tie bar is not fulfilling its function of supporting the panels in position.

In the background are the buildings of Jerusalem and above in heaven is the exact 'handed' design of the angel censuring that is found in the windowhead of Light a. The head and wings of this angel are intact, see *PHOTO 24*, but obscured by the metal sheeting in the cusps of the protective window OUTSIDE.

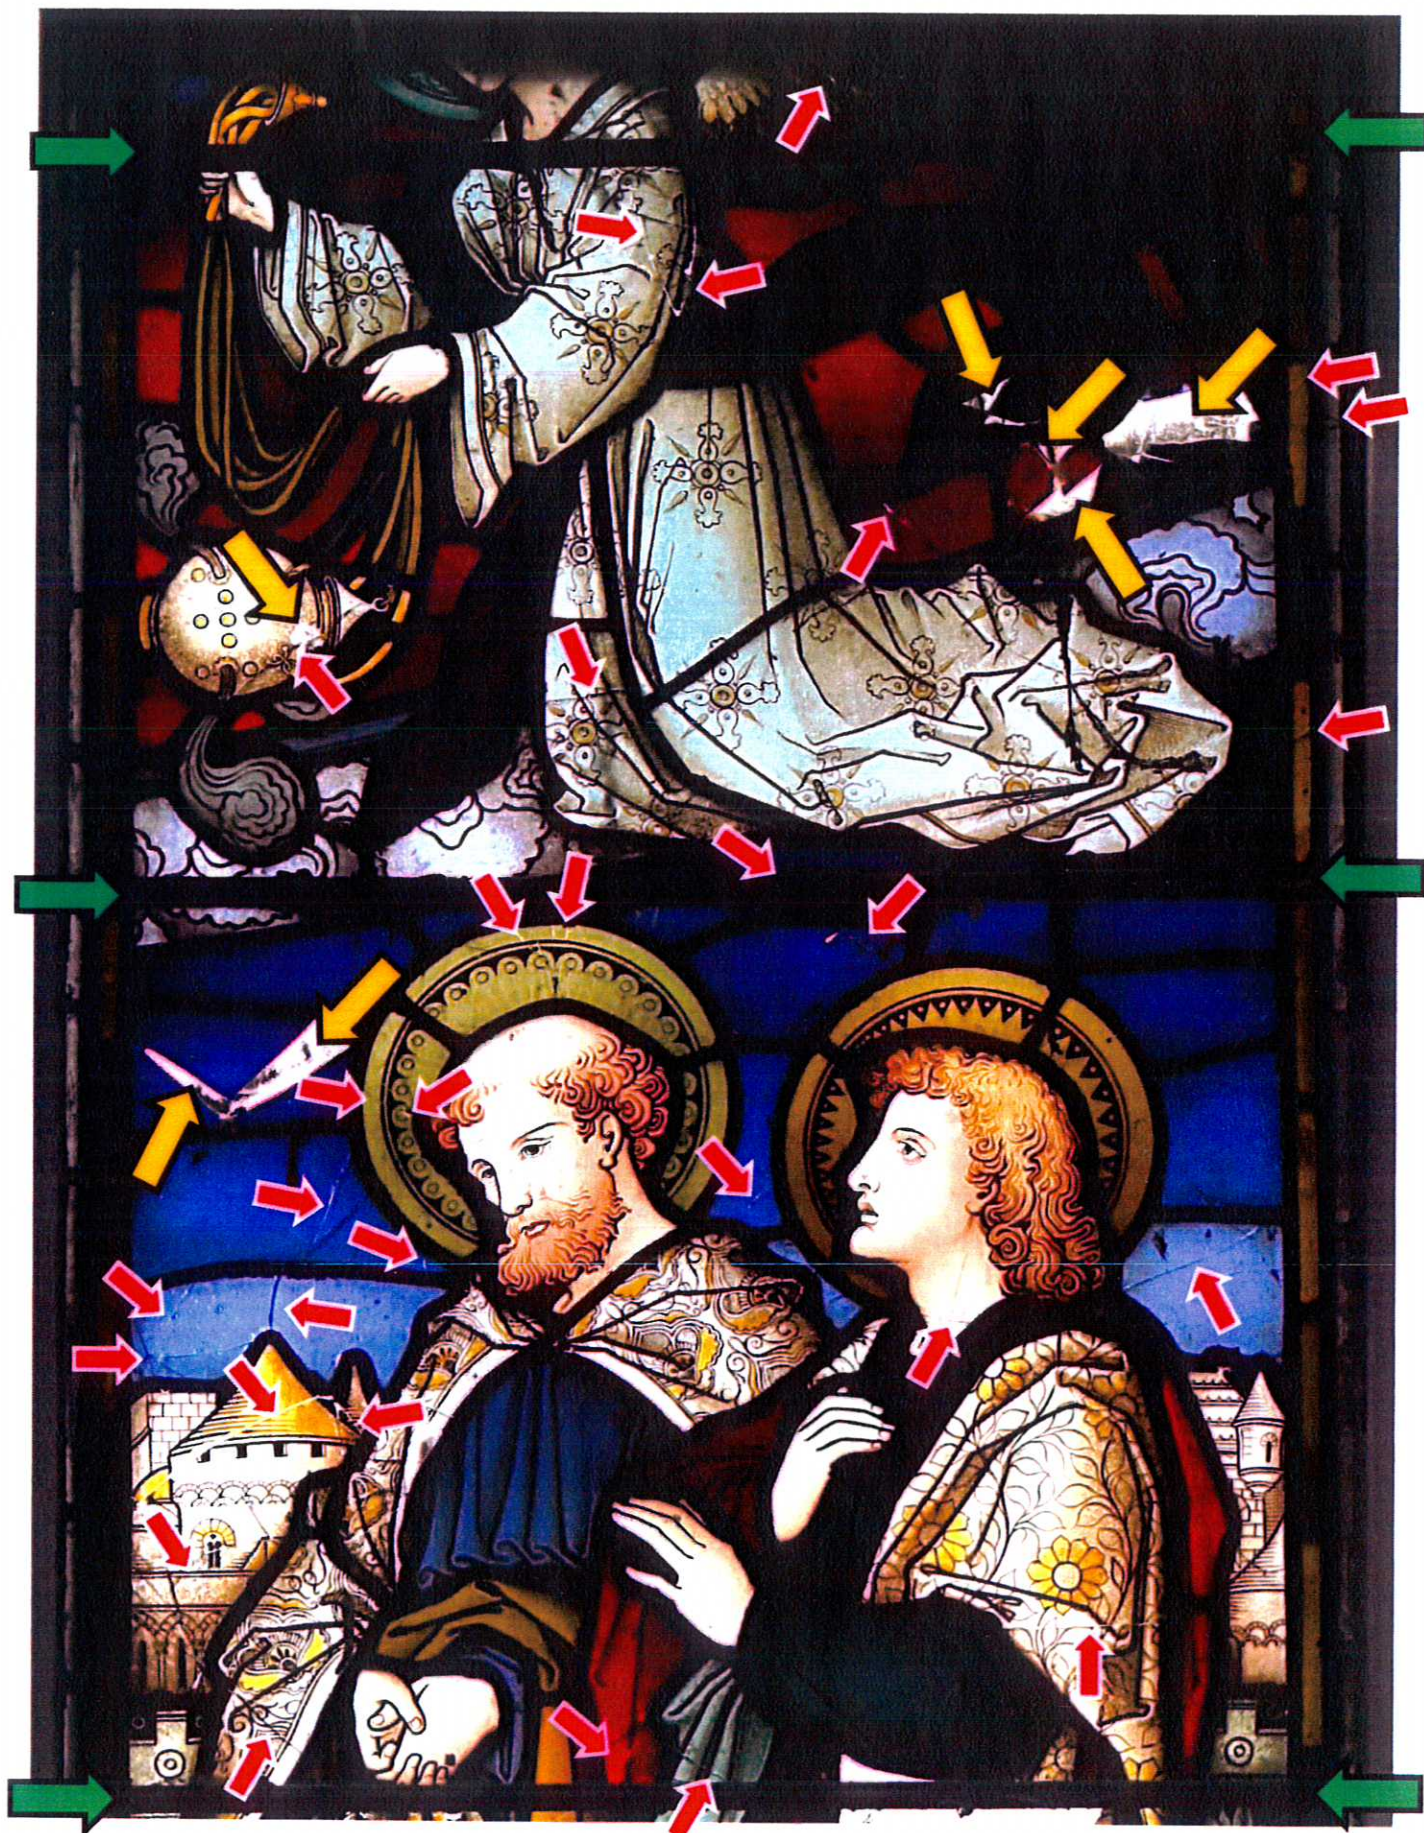
5.3 continued CUSPS of WINDOWHEADS of LIGHTS a, b and c

LIGHT 2a flash PHOTO23; PHOTO 26; LIGHT 2b flash PHOTO 25; PHOTO 26;
LIGHT 2c flash PHOTO 24; PHOTO 26 all taken 18.08.2011

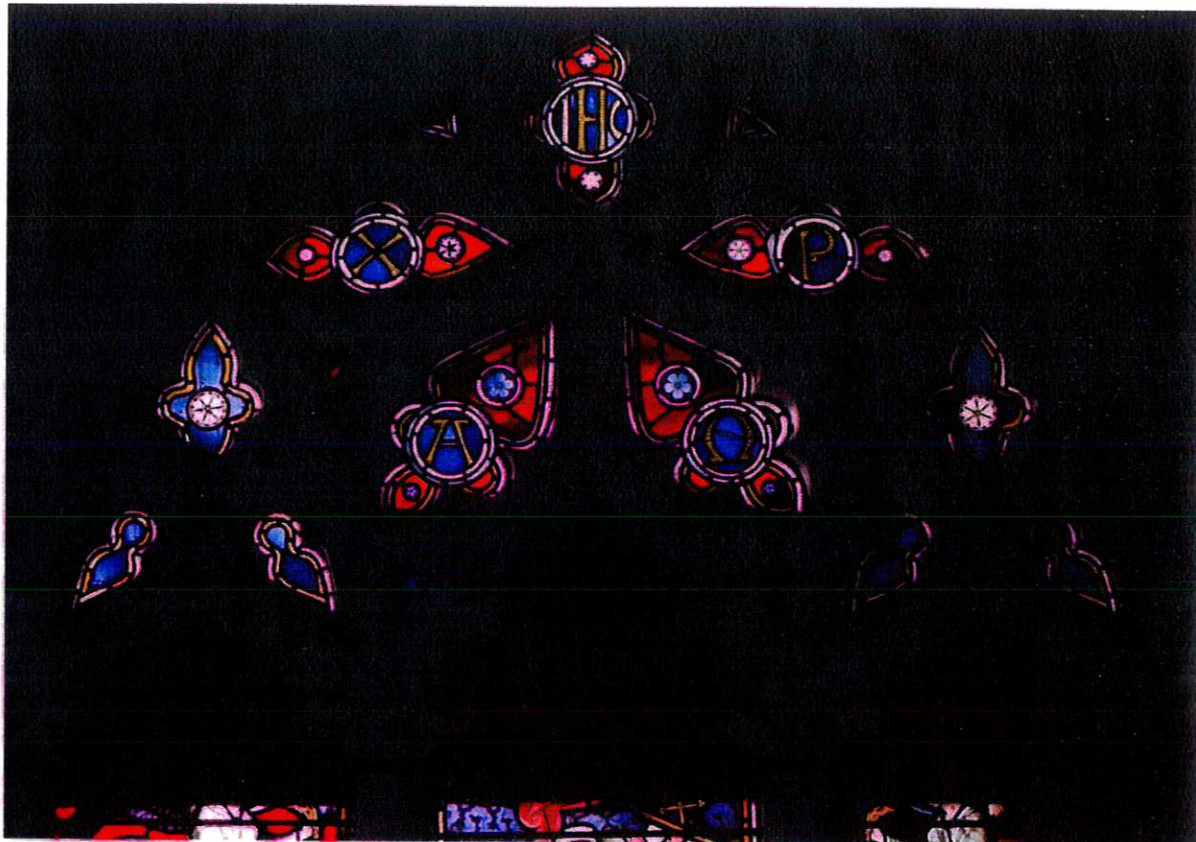
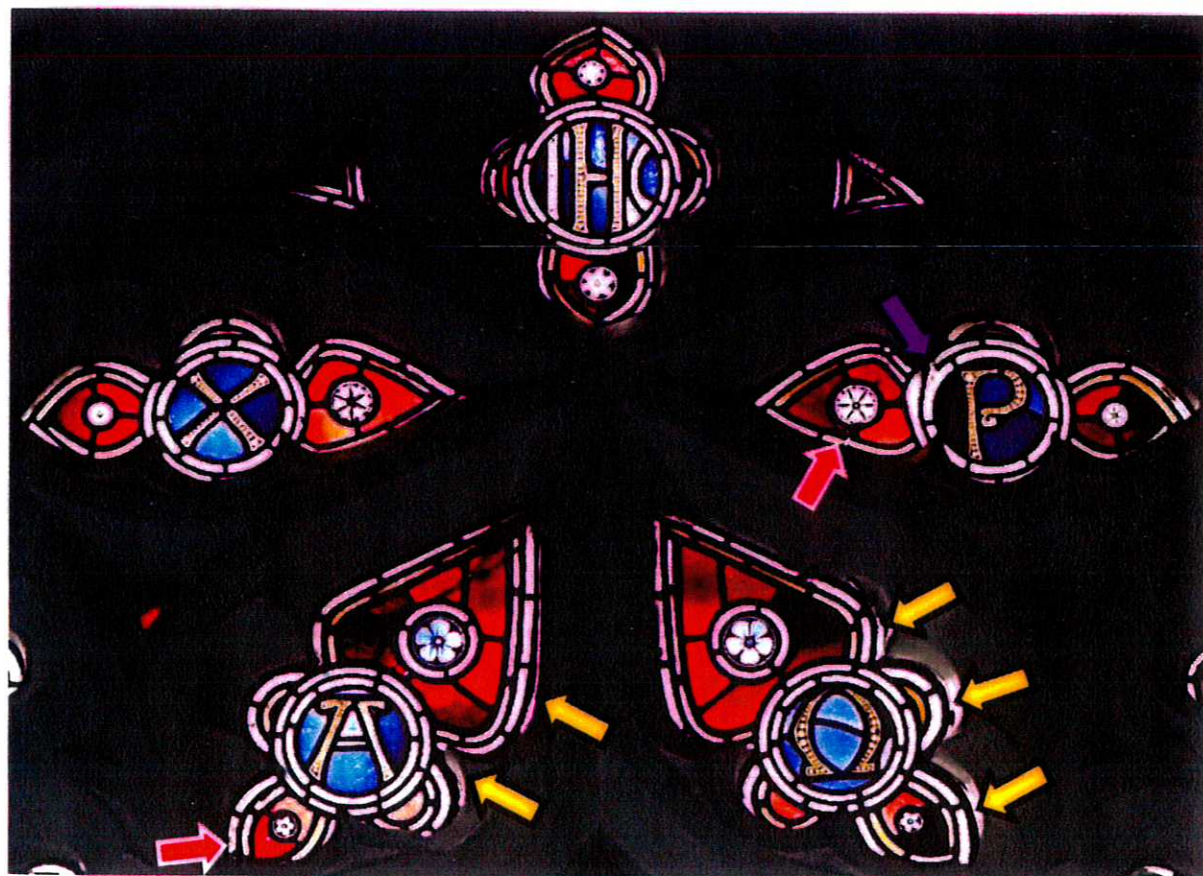
TRACERY LIGHTS see FIGURE 2 AND CUSPS OF LIGHTS a, b and c

PHOTO 26 above 18.08.2011 overall view including obscured cusps;

PHOTO 27 below 18.08.2011: TRACERY 5 Main Lights. Condition analysis page10

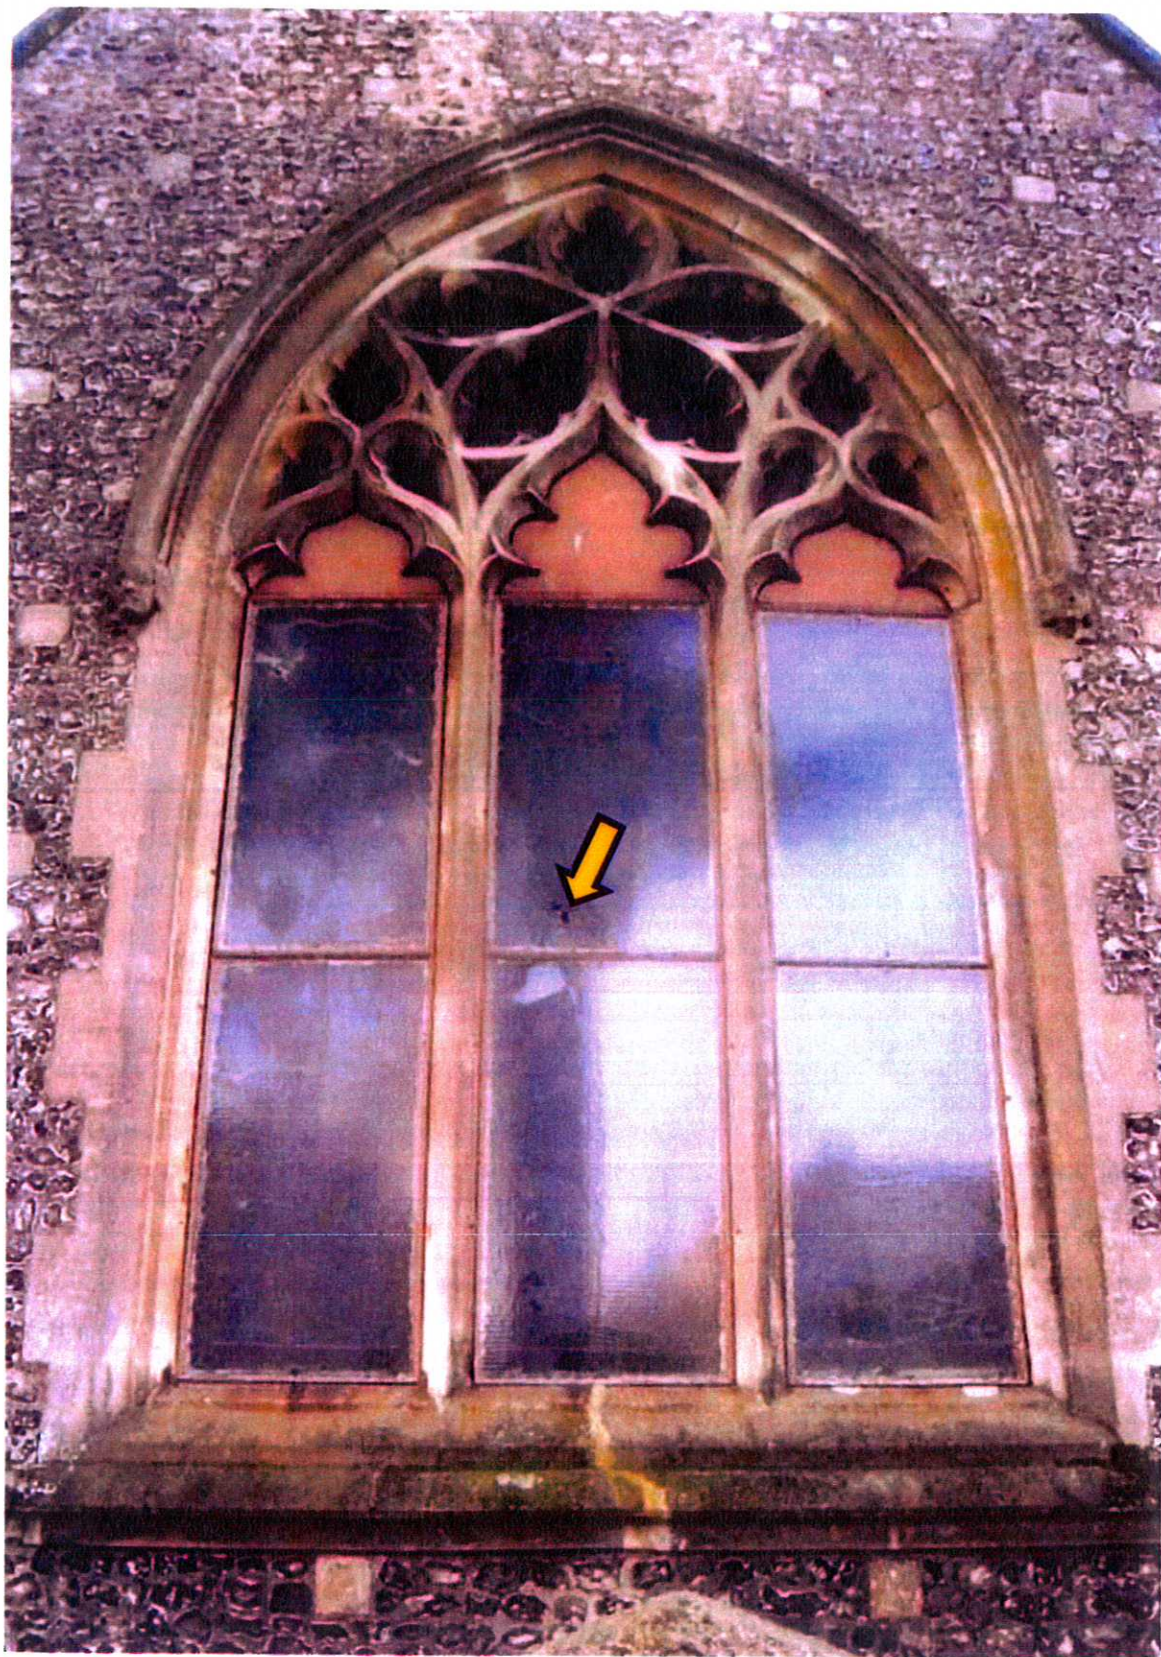
EAST WINDOW : OUTSIDE

PHOTO: 23.11.2010 Robert Holloway, Chapel Studio Herts
